Case History	Vibration due to Unbalance of Coupling	Rotating machinery
Self-Excited Vibration		(turbine & generator)

Power generation test turbine 100,000 rpm (Fig.1)

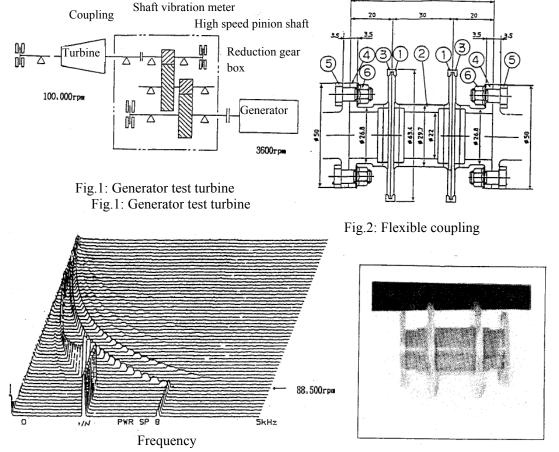
As a result of overhauling of each part in search of factors for increased unbalance, no specific abnormality was identified, except for peeling off in a spotty fashion of coupling paint.

Therefore, on an assumption that the coupling was the cause, investigation was made again to clarify the following three points, and we have come to a conclusion that the cause of increased vibration is peeling off of coupling paint.

Fig.4: Photograph showing splash of paint

Peeling off of paint -> occurrence of unbalance

After washing away all the paint on the coupling, residual unbalance on the single unit was reduced from 0.045 g·mm to 0.015 and 0.010 g·mm on both sides. As a result, the shaft vibration amplitude at 100,000 rpm was 15  $\mu$ m P-P, making stable test operations possible.

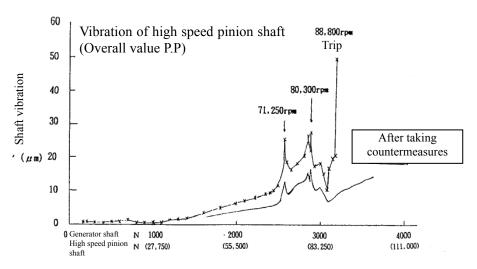
Fig.5: Vibration of high speed pinion shaft (O.A)

In particular, the peaks at 71,250 rpm and 80,300 rpm during acceleration shown in Fig.5 are in fairly good agreement with the results of preliminary analysis of bending-torsion coupled vibration. As there should be no calculation-based peak at 88,000 rpm, a cause investigation was conducted after obtaining the frequency analysis result (Fig.4) on the spot.
