Vibration	Abnormality of Piezoelectric Type Vibrometer	Rotating Machinery
Measurement

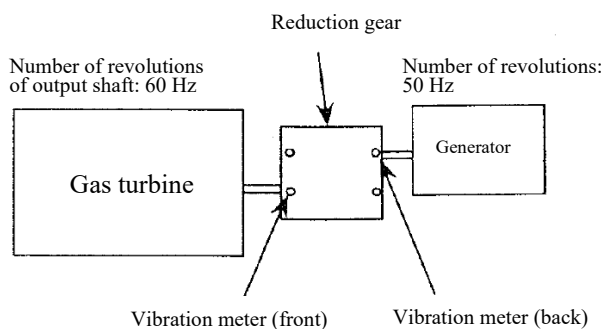
Fig.1 Gas turbine and vibration meter-attached position

Object Machine	Reduction gear for gas turbine generator (Fig.1) (46Mw, rotating speed; pinion side = 60Hz, wheel side = 50Hz)	
Observed Phenomena	When the load was increased during load operation, the output of a vibration monitoring vibrometer (piezoelectric type acceleration sensor) attached to four bearing parts suddenly increased and then the machine tripped. That is, immediately before tripping, the indication of vibrations started to fluctuate, and suddenly increased upon tripping (refer to Fig.2). The load condition in tripping had reproducibility in several times of operating speeds.	
Cause Estimation	As the vibration generating conditions differed from one of normal vibrations and, in particular, temperatures of the bearing parts (bearing holding rings) do not suddenly change as same as vibration change, a question arose if the measured vibrations were correct or not. As the vibrometer used was a piezoelectric type of acceleration sensor, there is a possibility that noises due to power source noises (50Hz) or low noise cable is vibrating.

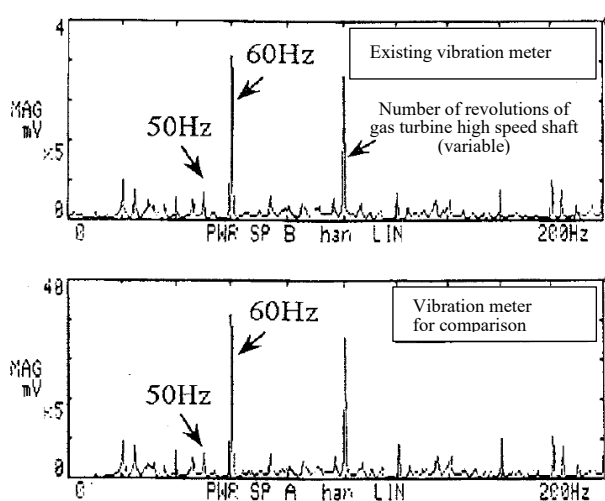
Fig.3 Output of gear vibration (front) under light load

Analysis and Data Processing	An acceleration sensor or dynamo-electric type velocity sensor (conventionally used and reliable sensor) is attached at the same position and perform comparative evaluation. As a result, it was found that the outputs of these two types of sensors under low load operations were similar (Fig.3), but a remarkable difference was observed between them under a condition of tripping (Fig.4). Frequency components considered abnormal were integer times (power source noises) of the power source frequency (50Hz) and frequencies of integer times of 10Hz (60 - 50Hz?) appeared as teeth of comb. It was also confirmed that noises also increased when power source of auxiliaries of generator (for lubrication system) was switched to the source of in-house generator(Fig.5). Thus, it was judged that the acceleration vibrometer was the source of trouble. There is a high possibility that a saturation phenomenon (clip) in the charge amplifier generates as cause that the noise occurrence condition greatly changes depending on the loading condition,

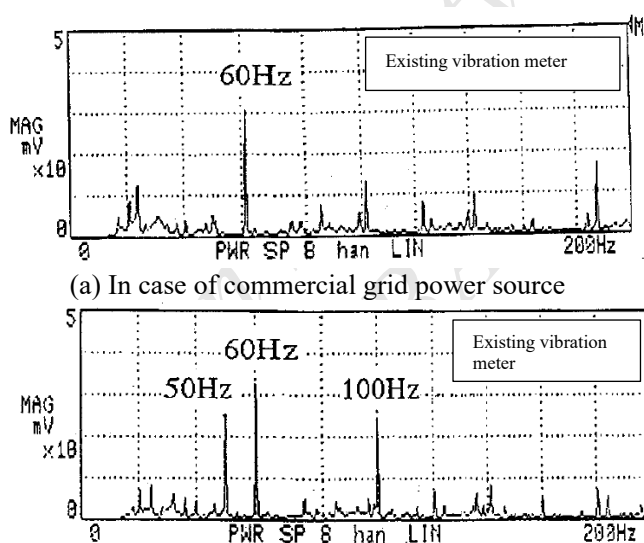
(a) In case of commercial grid power source  
(b) In case of in-house diesel generator power source  
Fig.5 Difference due to power source used for gas turbine auxiliaries

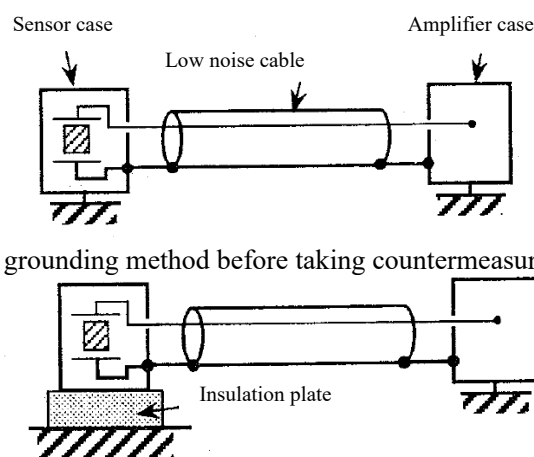
(a) Sensor grounding method before taking countermeasures

Countermeasures and Results	Power source noises may be reduced by means of grounding (earthing) of the measurement system. Thus, as shown in Fig.6, the differential grounding was changed to the single end grounding (amplifier case earthing). As the results, the occurrence of power source noises decreased (not completely eliminated) and no abnormal output resulted in tripping.	
Lesson	When using piezoelectric type acceleration vibrometers, we should pay attention to power source noises, vibration of cables, and saturation phenomenon of charge amplifiers. Attention must also be paid to commercially available sensors as they may have inferior performance.	
References	Nothing in particular.	
Keywords	Acceleration meter, piezoelectric type, seismic type vibration meter, power source noise, saturation phenomenon of charge amplifiers

(b) Sensor grounding method after taking countermeasure  
Fig.6 Noise countermeasures (changed to sensor grounding method)
