Vibration	Vibration due to Cavitation of Mixed Flow Pump	Rotating Machinery
Self-Excitation

Object Machine	Vertical mixed flow pump, 370min <sup>-1</sup> – 6.5m <sup>3</sup> /sec – 15.9m (Fig.1)	
Observed Phenomena	<p>During a large flowrate operation of a pump in the factory test, excessive vibrations (12-14mm/s-rms) in the vertical direction (shaft axial direction) and peculiar noises like a train sound were generated, but partial to rated flowrate operations experienced no problem.</p> <ul style="list-style-type: none"> <li>- Peculiar noises called a train sound like “choo-choo” were identified.</li> <li>- In the large flowrate area, excessive vibrations in the shaft axial direction with a frequency of 15 to 20Hz (non-synchronous with rotation) occurred, while this frequency varied depending on the flowrate.</li> <li>- In the frequency area of this vibration, there is no natural frequency of the structural system (verified by means of FEM and impact test).</li> </ul> <p>Thus, the above is assumed to be unstable vibrations due to cavitation of the pump suction portion.</p>

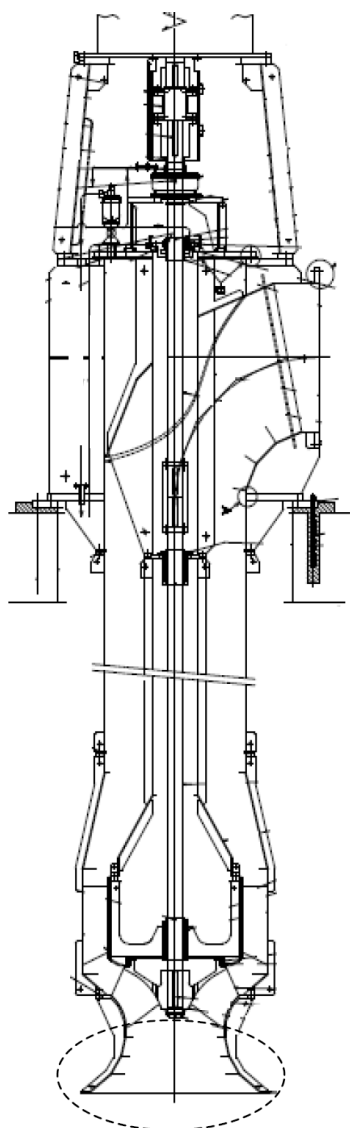
Fig.1 Vertical pump

Modification of suction flow passage for improvement

Countermeasures and Results	<p>[Countermeasures] The shape of a suction pump bellmouth was modified (to obtain a moderate and smooth aperture).</p> <p>[Results] Area of occurrence of excessive vibrations was shifted to the large flowrate area, thus no problem at all in the operation area. Shaft-directional vibrations of the bearing housing after taking countermeasures are given in Fig.4, which clearly indicates a sharp decrease in vibrations.</p>	
Lesson	<ul style="list-style-type: none"> <li>- Prior examination is essential because an unstable phenomenon of fluid involves a very high energy and dangerous</li> <li>- In this case, before conducting an analysis of measurement data, the cause was nearly determined by means of observation of the phenomenon (mainly noises) at site and hearing in the field, thus effective countermeasures were established (as a matter of fact, data analysis was conducted as a proof). Complicated problems may be solved much quickly by observing the phenomena at site, rather than just looking at data.</li> </ul>

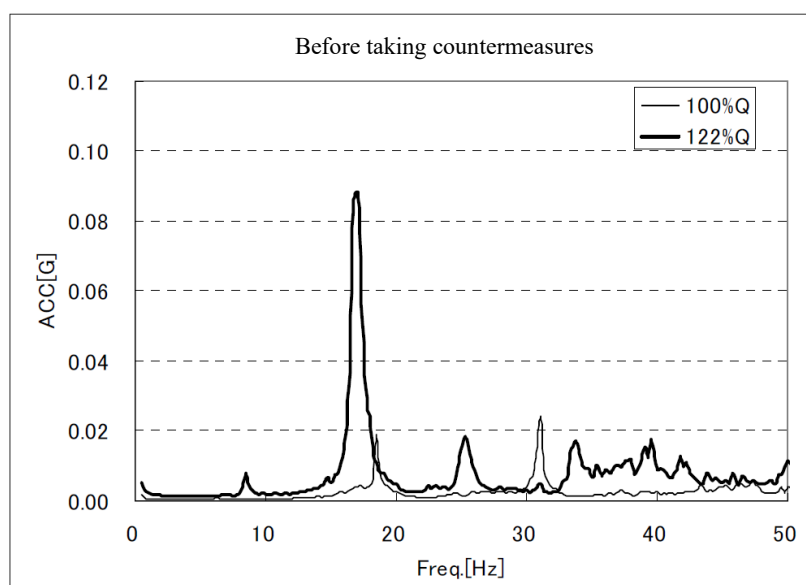
Fig.2 Vibration in the vertical direction of top bearing before taking countermeasures

Cause Estimation		
Analysis and Data Processing	<p>Fig.2 shows the frequency distribution of vibrations in the shaft axial direction of the bearing housing, where occurrence of excessive vibrations of about 17Hz was observed in the large flow area (122% Q<sub>opt</sub>). Judging from the fact that the suction level was considerably lowered or the shape of the flow passage was narrowed, and the peculiar noises (with a frequency nearly equal to that of the bearing vibrations), it was thought that unstable vibrations occurred due to cavitation caused by inadequate NPSH<sub>a</sub> (Net Positive Suction Head available). Changing the flowrate caused the dominant frequency of vibrations in the axial direction changing as indicated in Fig.3, which is characteristic of unstable vibrations due to cavitation when the cavitation number changes. In this case, vibrations suddenly increased at a frequency of about 17Hz. In this connection, it is considered that resonance occurred with the natural frequency of a liquid column of the tube in the factory layout (and also in a locked-in condition).</p>
