Chapter 3

Damage to Machines and Equipment, and Good Practices for Seismic Countermeasures

Report of the JSME Research Committee on the Great East Japan Earthquake Disaster

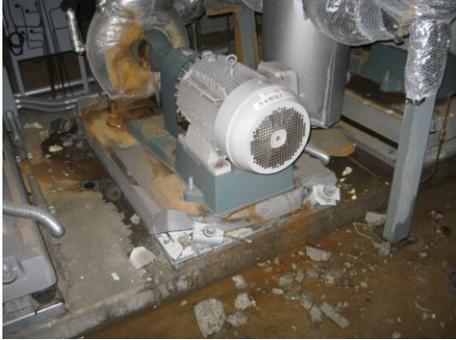
Figure 2 shows the damage at the base of a circulation pump. The concrete base and cast iron base were broken, and the anchor bolts were deformed by the seismic motion. Figure 3 shows an example of the deformation of an anchor bolt, and Fig. 4 shows the deformation of a steel base of a FRP tank. In many cases, equipment installed on the roofs of buildings, such as air conditioning units, had collapsed or failed because the seismic response of buildings tends to be amplified at the top. Figure 5 shows examples of such damage. This kind of damage, which is related to bases and anchors, mainly occurred due to a lack of consideration of earthquake resistance when installing the equipment. Figure 6 shows damage to the anti-vibration bar of a boiler. The boiler was suspended from the upper position only in order to allow for heat expansion during operation; consequently the seismic response was large and the body of the boiler collided with the anti-vibration bar, damaging it.

Fig. 2 Damage at the base of a pump

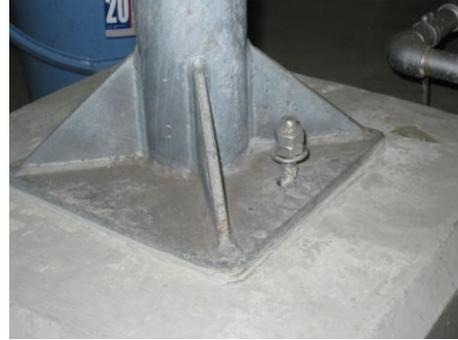
Fig. 3 Deformation of an anchor bolt
(Provided by JAXA)

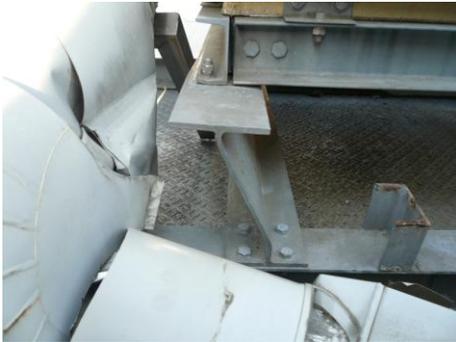
Fig. 4 Deformation of the steel base of a FRP tank

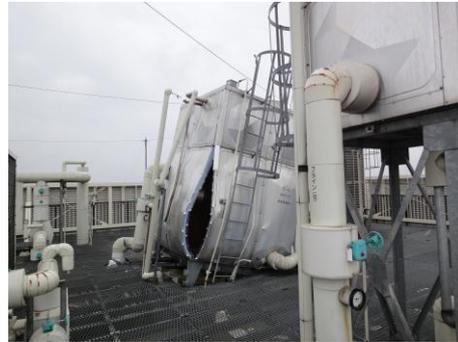
Fig. 5 Failure of a water tank installed on a roof

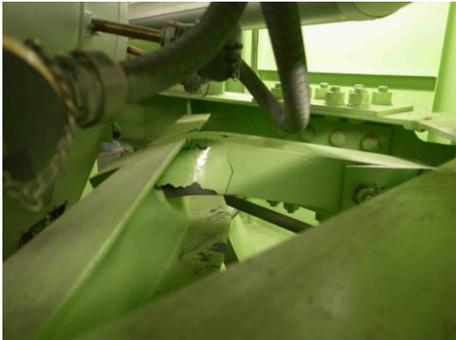
Fig. 6 Damage to the anti-vibration bar of a boiler

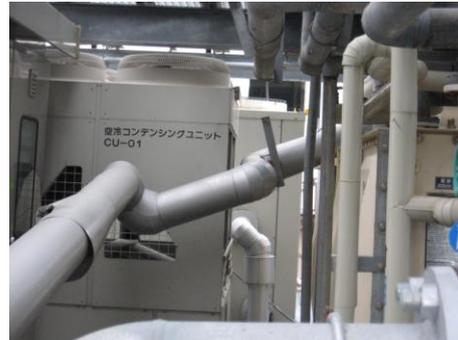
Figure 7 shows the failure of pipe supports and Fig. 8 shows damage to utility pipes. The failure of the pipes occurred mainly at the pipe supports or connections with other equipment. The leakage of water from the damaged pipes often caused secondary damage such as moisture damage to books and documents or problems with electrical equipment. To prevent such secondary damage, it is necessary to consider the facility layout in the planning stage as well as the seismic resistance of the piping system. Another pipe-failure mode was related to soil deformation and is described in section 3.2. Figure 9 does not show pipe failure itself, but rather failure related to a pipe's seismic response. The different seismic responses of the pipes and the building caused damage at the inner wall.

Fig. 7 Failure of a pipe support (in-house hanging pipe)

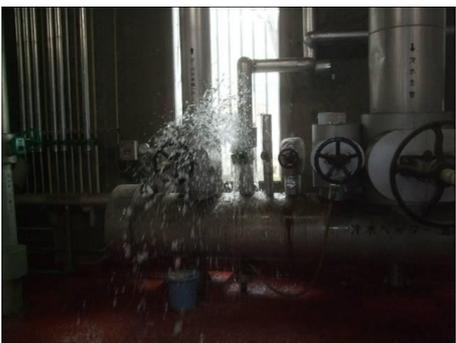
Fig. 8 Failure of a utility pipe and water leakage
(Provided by JAXA)

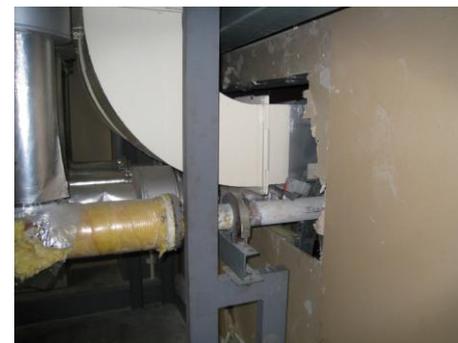
Fig. 9 Damage to inner walls by pipes
(Provided by JAXA)

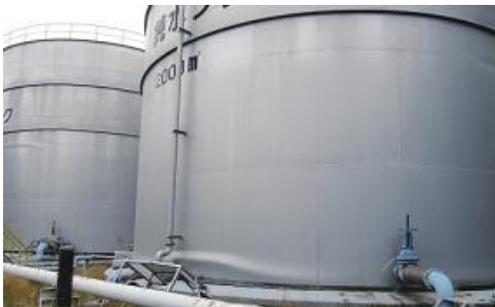
The buckling failure of tanks has been reported after previous earthquakes, such as the 1995 Kobe Earthquake and the 2007 Niigata-ken Chuetsu-oki Earthquake; this failure mode was also found to result from the GEJE. Figure 10 shows the buckling failure of a 2,000 m³ water tank (Thermal and Nuclear Power Engineering Society, 2011). This

failure was caused by the aftershocks on April 11 and 12. There were some tanks that did not sustain damage, despite being located in the same prefecture as the failed tanks. Thus, it is necessary to investigate the cause of these failures taking into account the characteristics of the seismic motion along with other factors. The damage investigations at hazardous material facilities were conducted and summarized by the National Research Institute of Fire and Disaster. According to their report, the damage caused by sloshing liquids occurred in the Tokyo Bay area and the Sea-of-Japan side of North Japan (Nishi, 2012).

Fig. 10 Buckling failure of a 2,000 m³ water tank (Thermal and Nuclear Power Engineering Society, 2011)

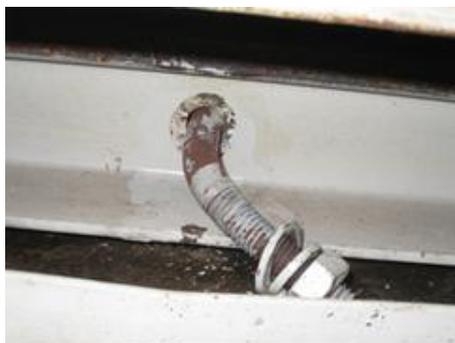
Fig. 12 Elongation of a hook bolt

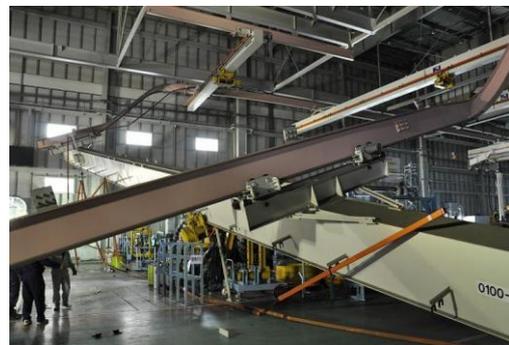
Cranes and unloaders were also damaged by the earthquake and damage investigations were conducted by the Japan Crane Association (JCA) (Japan Crane Association, 2011). Figure 11 shows the number of damaged cranes with respect to crane type, revealing that it was mainly overhead cranes that were damaged by the seismic motion. Figure 12 shows a typical failure of an overhead crane. The hook bolts that held the crane rail deformed or fractured. Figure 13 shows another failure mode of an overhead crane. The failure occurred at the welding point at the suspension of the crane rail.

Fig. 13 Failure mode of an overhead crane (fallen rail)

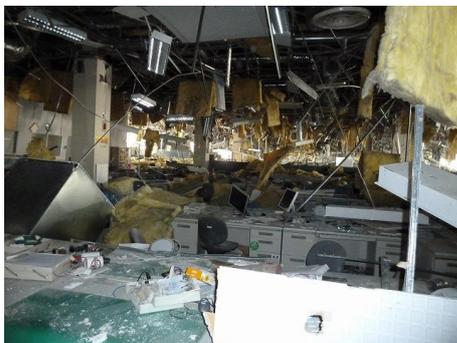
Fig. 14 Fallen ceiling materials

The ceilings and walls of factory buildings and equipment hung from the ceilings such as cable racks and air-conditioning units were also damaged. Figures 14 and 15 show some examples of these types of damage. Such incidents led to human injuries, secondary damage to machines, and hindered the resumption of business operations.

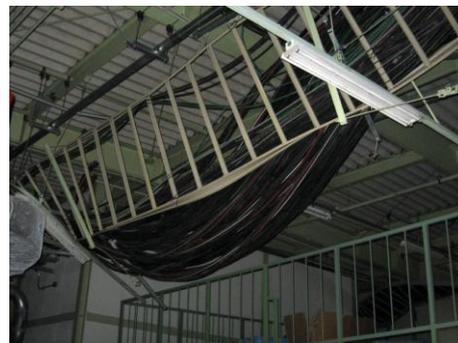
Fig. 15 Failure of cable racks

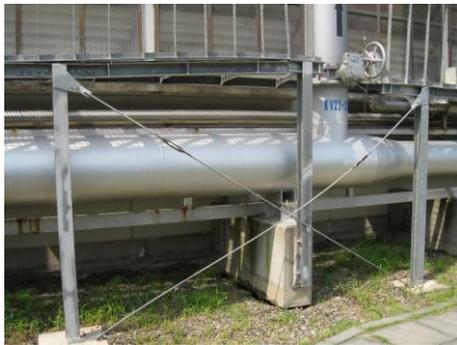
Fig. 16 Uplift of a pipe support base due to ground subsidence

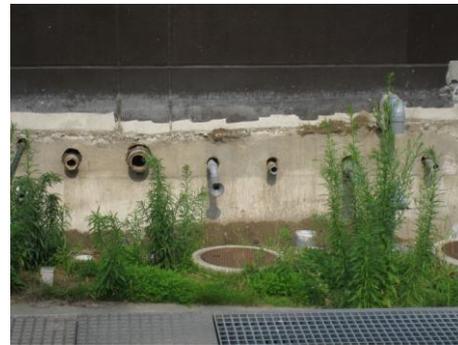
Fig. 17 Pipes fractured at the connection point of the building and soil

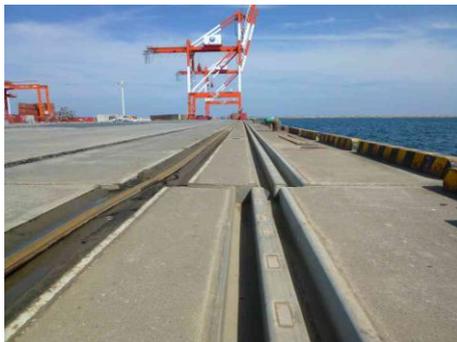
Fig. 18 Quay wall deformation and misalignment of the unloader rail

run on the deformed rail, although the crane itself was undamaged. There were many cases in which damage was observed at smaller facilities that surrounded larger or more important sites. This is mainly because the satellite facilities are set on different bases from the main facilities, for which less consideration is given to seismic countermeasures. Such instances were common in previous earthquakes also. Although not a mechanical structure, damage to a road in a research facility is shown in Figure 19. In this case large soil deformation slowed recovery, because the heavy machines necessary for making repairs could not be transported to the facility via the damaged road.

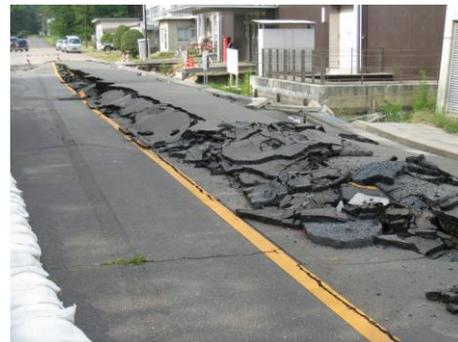
Fig. 19 Damage to road due to ground subsidence

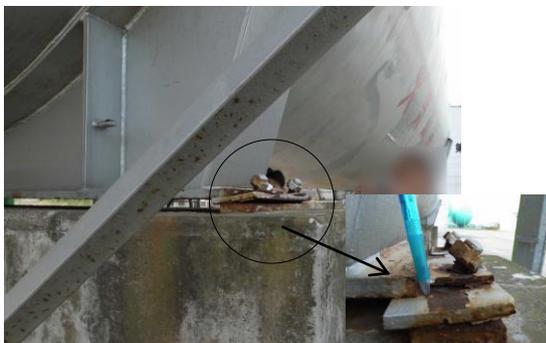
Fig. 20 Lifting damage to LPG tank by tsunami

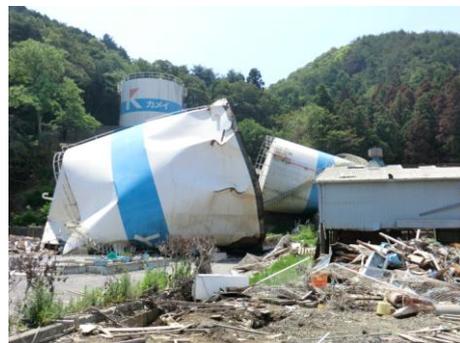
Fig. 21 Tanks washed away by tsunami

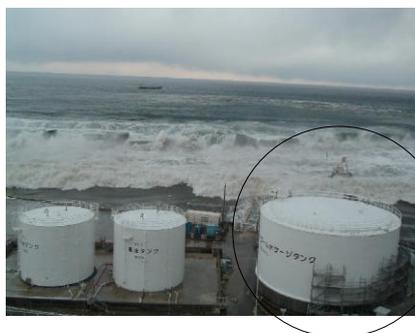
Fig. 22 Buckling failure of a water tank due to the water pressure (Provided by TEPCO)

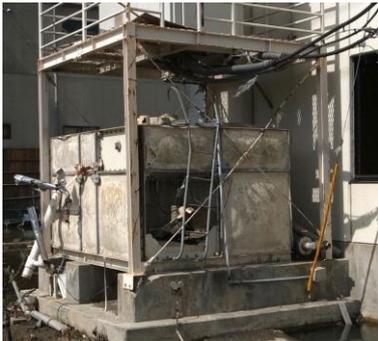
Fig. 23 Failure of a FRP tank caused by the tsunami

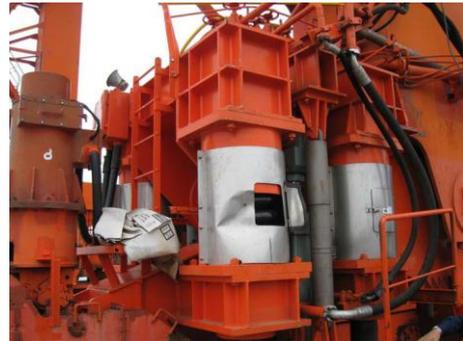
in Fig. 24 (Japan Crane Association, 2011). This container crane had an isolation system at the bottom and was not damaged by the seismic motion. However, wreckage hit the cover of the device and deformed it. Salt damage also occurred due to tidewater flooding. In many cases, electrical systems and devices including power panels required inspection, cleaning, and replacement after the tsunami. In addition, the large amount of rubble left after the tsunami hindered the disaster-relief at industrial facilities (Thermal and Nuclear Power Engineering Society, 2011). The tsunami affected near-sea level facilities, but no damage was sustained by elevated sites. Thus, it is effective to install essential equipment in elevated areas.

Fig. 24 Damage due to collisions with floating objects (Provided by TEPCO)

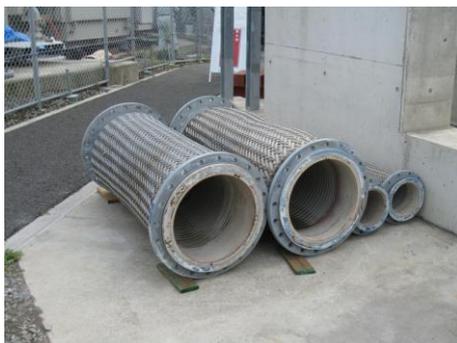
Fig. 25 Flexible pipes

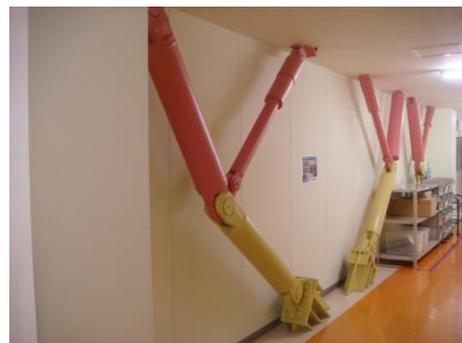
Although many industrial facilities and mechanical structures were damaged by this earthquake, the damage sustained by some facilities was mitigated by seismic countermeasures put in place before the earthquake. Many organizations took safety precautions such as fixing machines and furniture to the floor or building walls and preventing objects from falling from racks. Anchor bolts of a diameter sufficient to withstand seismic motion were effective for securing machines. As described in section 3.2, many pipes were damaged by the relative displacement between buildings and the surrounding soil. In such cases, flexible pipes such as those shown in Fig. 25 effectively overcame the problem. The application of base isolation systems or vibration control devices was also effective for reducing the movement of mechanical structures. Figure 26 shows an example of a vibration control brace in a facility building.

Fig. 26 Vibration control brace
