Chapter 7

Damages to Energy Infrastructures

1. Damage survey of power plants

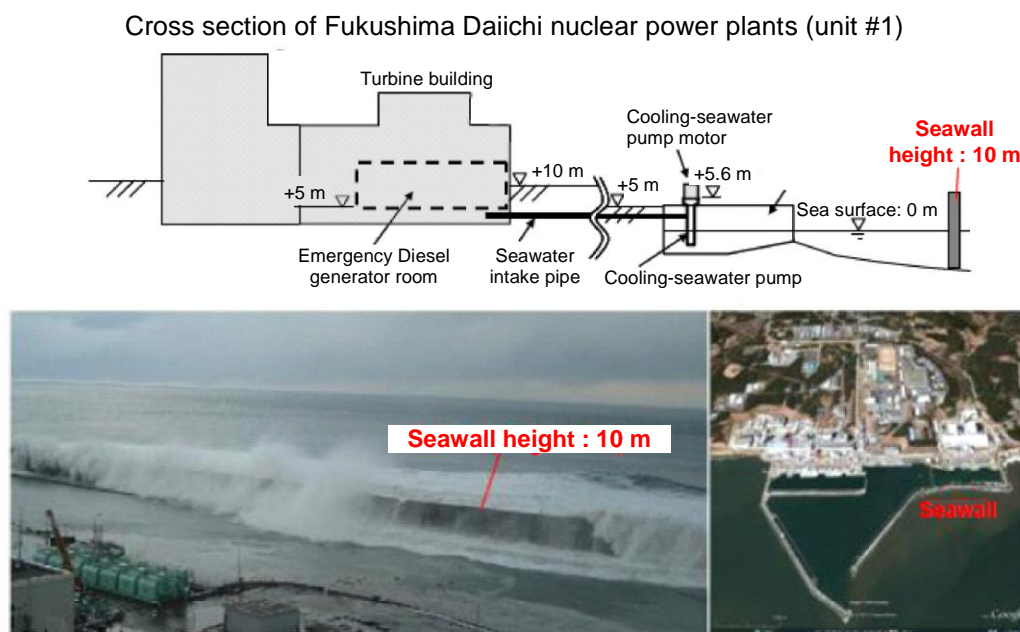
Figures 2 and 3 show the tsunami hitting the Fukushima Daiichi nuclear power plant and the reactor buildings damaged by the hydrogen explosion that was caused by the subsequent station blackout and core meltdown, respectively. Based on the results of the investigation and analysis of the accident at the Fukushima Daiichi nuclear power stations, the following important technical issues were recognized: (a) important equipment such as emergency batteries and emergency generators should be stored or located in water-resistant areas, and (b) power-supply cars and switchboards should be placed on higher ground. An investigation was also conducted on the accident management. First, it was estimated that the nuclear reactor core of unit #1 was under complete exposure before 18:00 JST on 11 March 2011 (Aritomi, 2012). This implies that there was only a very limited amount of time during the accident management to avoid serious outcomes, such as the release of radioactive materials into the environment. Furthermore, it was considered that the persons in charge at the site, the central office of the Tokyo Electric Power Company and the headquarters of the Japanese government, did not adequately recognize the aforementioned serious situation. Understanding the spatial and temporal development of the events expected after the occurrence of an accident and the information of the plant status are the basis used to take appropriate accident management procedures. Therefore, instrumentation systems to determine the plant status should be available under any circumstances. During the past 40 years, since unit #1 of the Fukushima Daiichi nuclear power plant began full operation, various experiences and effective safety measures pertaining to a possible nuclear power plant accident, including TMI-2, have accumulated (U.S. NRC, 2002). Additionally, the outcomes of the researches on severe accidents carried out by the Japan Atomic Energy Agency (JAEA) and Japan Nuclear Energy Safety Organization (JNES) were reported (Nariai, 2011), but the knowledge obtained from these was unfortunately not used sufficiently for “kaizen” or for the improvement of the existing nuclear power plants in Japan. In the investigation report of the TMI-2 accident that was published over 30 years ago, it was already pointed out that when new knowledge is obtained, it should be applied immediately to existing plants to extract new important issues, maintain the effort for kaizen, and to re-examine the institutional design (President’s commission on the accident at Three Mile Island, 1979). In addition, unit #1 was developed by the General Electric Company as a turnkey project; in other words, unit #1 was not developed by JSME. In view of this, it may be obvious that it was of particular importance to thoroughly investigate the previous accidents at nuclear power plants and the outcome of severe accident research to improve the safety features of nuclear power plants in Japan. As a

Fig. 2 Layout of the seawall and an image showing the tsunami hitting the Fukushima Daiichi nuclear power plants.

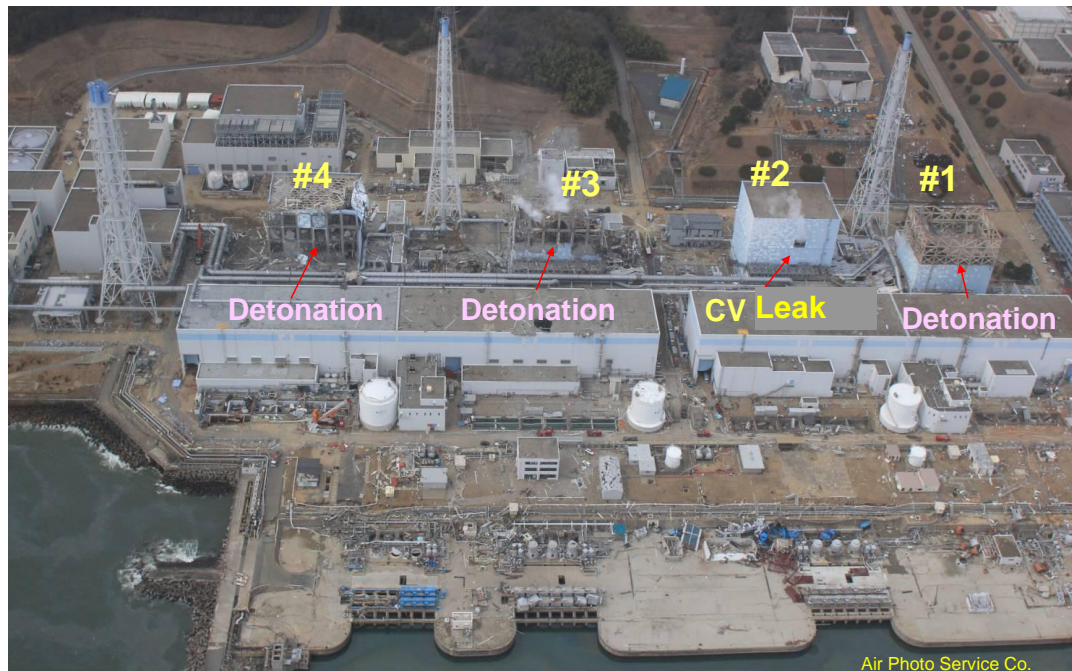
Fig. 3 Reactor buildings of the Fukushima Daiichi nuclear power plants after the occurrence of the hydrogen explosions (Courtesy of Air Photo Service Co.).

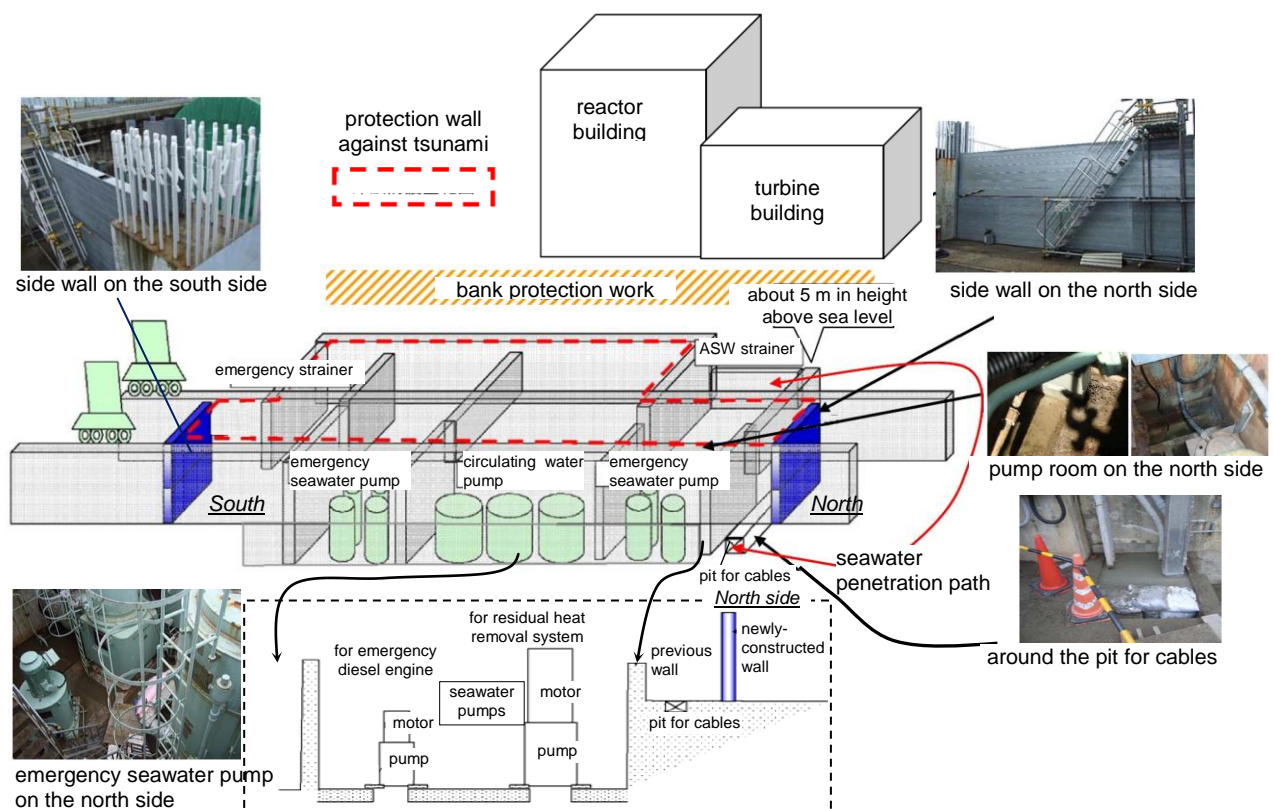
Many important lessons were also learned from the events that occurred at the nuclear power plants (NPPs) other than the Fukushima Daiichi nuclear power plant. At the Tokai Daini nuclear power plant, the Japan Atomic Power Company increased the height of the wall surrounding the seawater pump and improved the water-tightness of the penetration sections; these measures were taken before 11 March 2011 in response to a map that showed where flooding caused by a tsunami was expected, as provided by Ibaraki Prefecture in October 2007. As a result of implementing these countermeasures, two out of the three seawater pumps for the emergency diesel generators were able to avoid the flooding caused by the tsunami (Fig. 4). The Fukushima Daini nuclear power plant was struck by a tsunami that was higher than expected, but a cool shutdown was achieved by prompt operations, which included the implementation of temporal electric cables and the transportation and placement of alternative pump motors (Fig. 5). This confirmed the importance of preparing backup systems, creating manuals for accident management, and ensuring the use of alternative equipment. In the Onagawa nuclear power plant, an electrical short circuit occurred in a high-voltage power panel and caused a fire, which threatened the seismic class-S equipment. As for the Fukushima Daiichi nuclear power plant disaster, the seismic class-S equipment of the nuclear power plant units that were investigated was not damaged due any of the earthquake motions. Thus, it can be considered that the precautionary measures taken for earthquake motions were appropriate. However, a re-examination is required for the possibility that the functionality of the class-S equipment was influenced by the damage of the class-B and/or C equipment caused by the subsequent fires. Another notable event occurred at the Onagawa nuclear power plant. During this event, although the tsunami height was less than the ground height, several pumps were flooded due to the tsunami, which caused the emergency diesel generators to fail. The top of the box containing the tide indicator was blown off due to the increase in sea level caused by the tsunami. As a result, the reactor building was connected to sea to cause the flooding of the reactor building by the sea water (Fig. 6). The box top was very weak because the tide indicator was added after the nuclear power plant began operating without taking the risk of flooding into careful consideration. This is an important example that shows that meticulous attention is needed when implementing countermeasures to ensure water-tightness.

Fig. 4 Layout of the seawater pumps for the emergency diesel generators at the Tokai Daini nuclear power plant (The Japan Atomic Power Company, 2011).

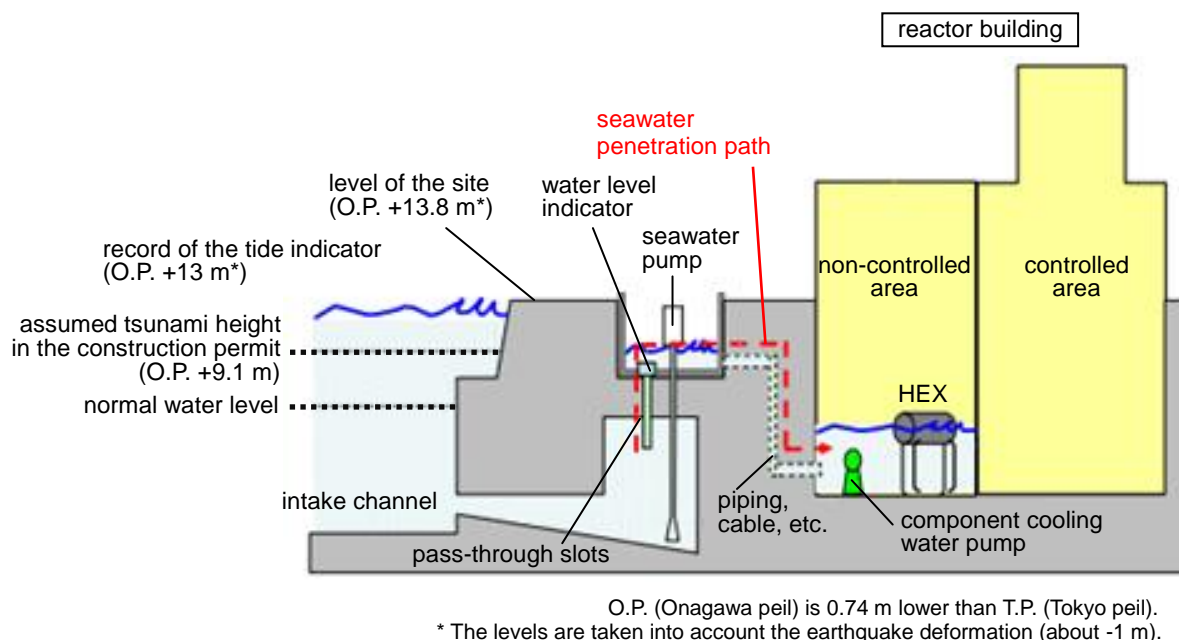
Fig. 6 Image showing how the building next to the nuclear reactor building of unit #2 flooded at the Onagawa nuclear power plant (Tohoku Electric Power Company, 2011).

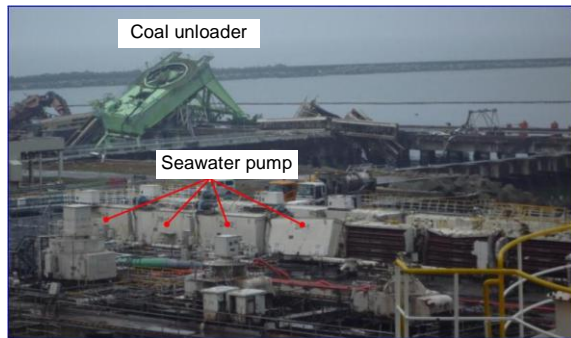
(a) Damaged coal unloader and sea water pump.

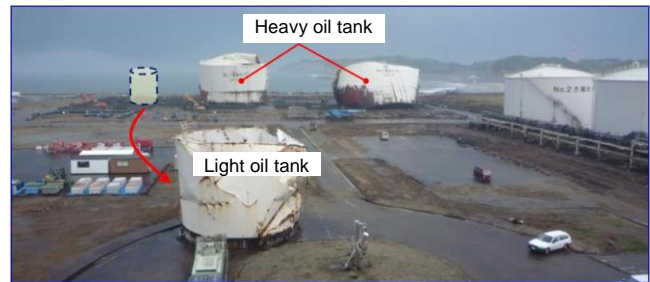
(b) Damaged light and heavy oil tanks.

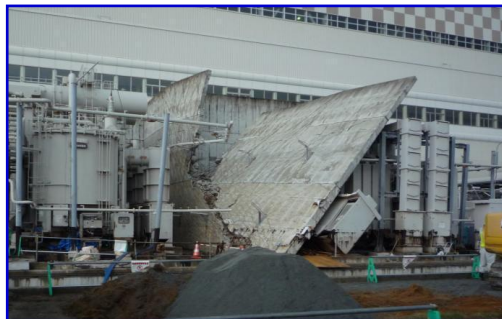
(c) Damaged concrete wall.

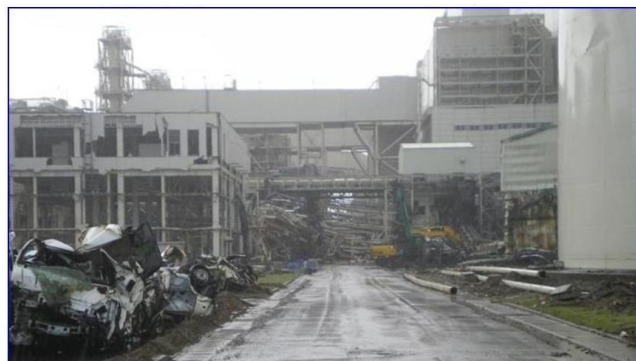
(d) Damages to unit #1.

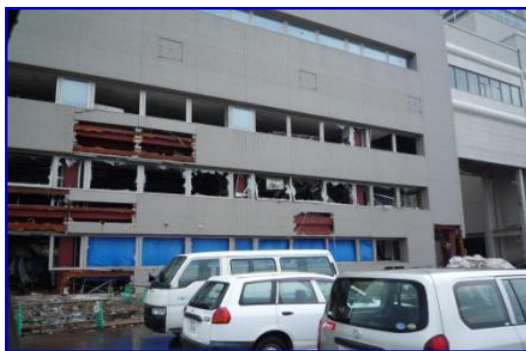
(i) Wall facing the sea.

(e) Damaged service building.

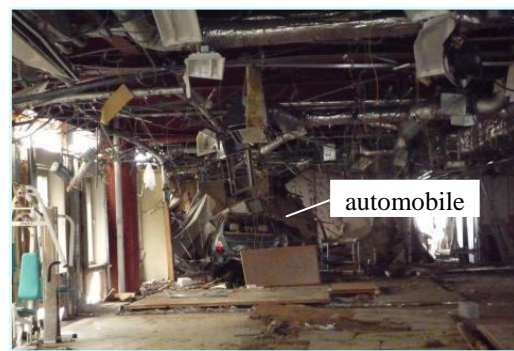
(ii) The 2nd floor.
