Case History	Low Frequency Whirl by Rotating Stall in Multi-Stage Turbine Pump	Rotating machinery (pump & water turbine)
Forced Vibration

Object Machine	Multi-stage turbine pump for boiler feed (general arrangement shown in Fig.1) Rotational speed of pump = 2,980 (rpm), pump head = 850 m, and rated discharge rate of pump = 3.8 (m ³ /min)	
Observed Phenomena	About three months after commencement of operation of the boiler feed pump, steam leakage occurred from the pump shaft sealing equipment. This was caused by whirling of shaft at a low speed (3.75 Hz) during mini-flow operation, which was able to be visually identified by watching the shaft rotation. Thus, the rotor vibration was measured, and at the same time vibration frequency analysis was conducted. The results are shown in Fig.2.	
Cause Presumed	As indicated in Fig.2 "Frequency analysis of rotor vibration", it was found that (1) whirl occurred when the pump discharge rate was at about 30% or less of the design flow rate, (2) the direction of whirl matched the direction of rotation, and (3) the period of whirl is as low as 7.5% of the rotational speed of the pump, while the shaft system had no such natural frequency. Judging

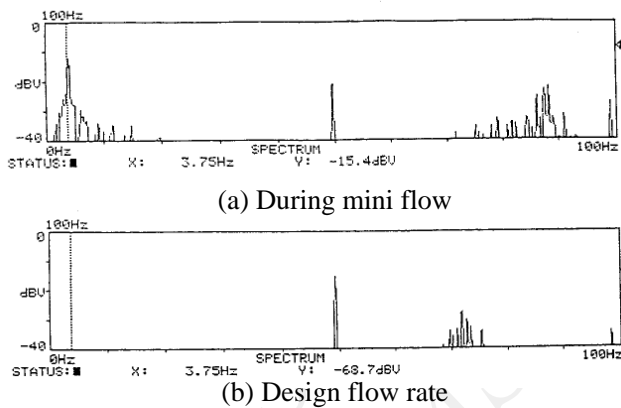
Fig.2: Frequency analysis of rotor vibration

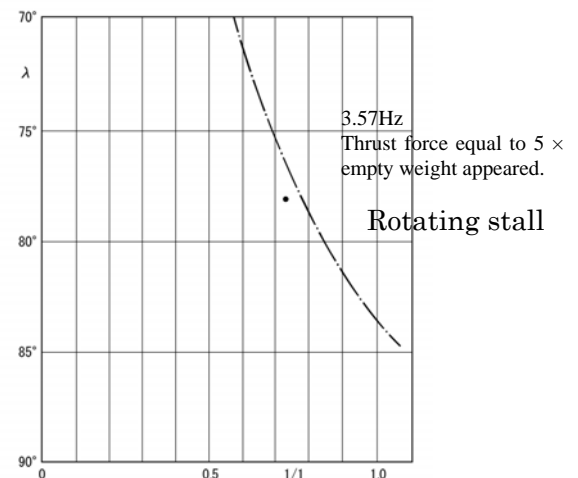
Fig.4: Relationship between rotating stall and diffuser parameters

Analysis and Data Processing	<p>Based on the above cause estimation, the following investigations were conducted.</p> <p>(1) The impeller wear ring was replaced with another shaped one having a large supporting force. As a result, the amplitude of swirl decreased together with a slight reduction in sliding flaw on the rotating body and the fixed part. However, this did not prove to be a radical solution for whirl at minimum flow.</p> <p>(2) Investigation of hydraulic force acting on the impeller due to rotating stall: Fig.3 illustrates an example of measured data on hydraulic force acting on the impeller upon occurrence of a rotating stall. Estimation of a radial thrust applied to the actual pump rotor based on these data indicated that the thrust force would be 520 kgf when all forces on the impellers were in synchronism. Given the pump shaft system span, it was understood that shaft deformation could cause leakage from the shaft sealing equipment, if such a thrust force was applied. Fig. 4 shows the relationship between the area where diffuser rotating stall developed and the diffuser shape. The diffuser of this pump lies within the rotating stall area, which is believed to be the cause.</p>

Countermeasures and Results	<p>(1) Examination of change of diffuser design</p> <p>(a) To have intentional eccentricity of the center of hydraulic force of the diffuser and the impeller.</p> <p>(b) To make asymmetric along the shaft center the inlet shape of the diffuser vane.</p> <p>Based on the above, countermeasures were planned not to allow rotating stall to occur. Before applying these countermeasures to the actual pump, their effect was checked by means of a model test, which revealed that, although the whirling force of the impeller was reduced, it was not completely eliminated. Accordingly, instead of changing the pump hydropower unit, the minor piping around the pump was modified, thus increasing the mini flow rate.</p> <p>(2) Modification of the shape of impeller wear ring As for the pump body, the shape of the wear ring was modified to enhance the shaft stiffness. In consequence, the problem in using the pump was solved.</p>
