Vibration	Vibration Problem of Straightening Plate for Steam Reheater	Plant
Resonance

Object Machine

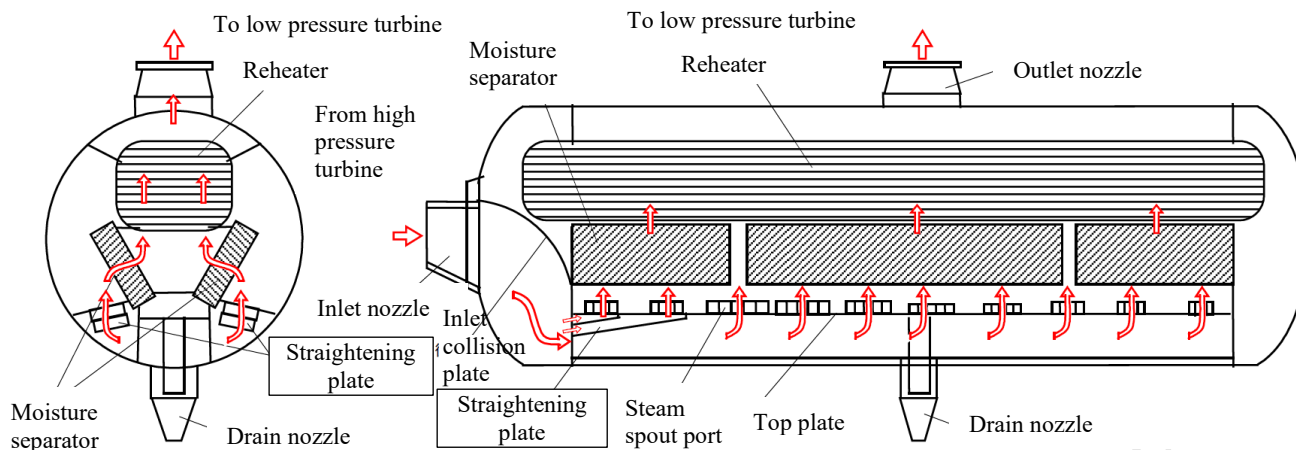
Steam reheater containing a set of equipment for separation of moisture contained in steam and for reheating the steam within the same vessel between the high pressure and low pressure turbines of a power station (Fig.1). At the inlet, temperature is about 180°C, pressure about 1MPa, and moisture about 12%. Straightening plates having two stage-flow passages are installed in order to guide the inflow steam to the steam ejection opening at the inlet.

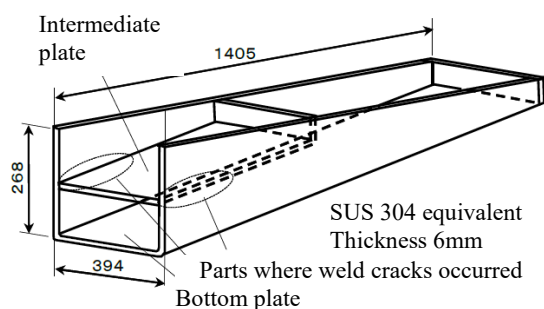
After one month from commencement of operation of the equipment, abnormal sound was confirmed in the equipment during the constant operation of rated thermal output. By Internal inspection after the plant shutdown, identified a large crack at the welding points on both sides of the intermediate plate of the straightening plates as shown in Fig.2.

By inspection and investigation, fault was found in the welding points and striation was observed on the fracture face. High speed steam flow into the inlet of the straightening plates in the obliquely downward direction, and a high cycle excitation force due to separation vortex occurring from the leading edge of the straightening plates was amplified by an air column resonance, which acted on the plates to cause vibrations, resulting in weld cracks.

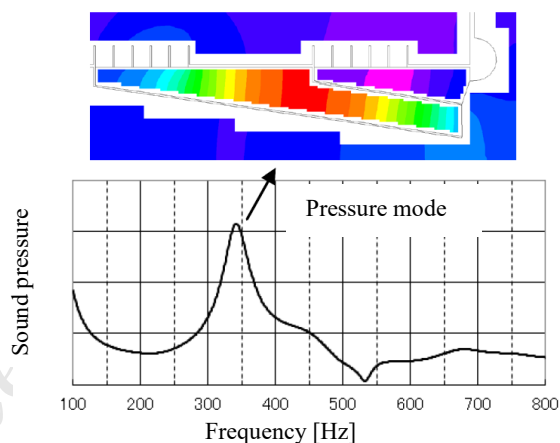
Fig.6 shows the power spectrum density of differential pressure between the top and the bottom surfaces of the bottom plate. Applying the mist increases the value of PSD, while PSD had the same value for three different mist particle sizes. An acoustic analysis using the boundary element method shown in Fig.7 confirmed that a peak around 330 Hz was caused by an air column resonance, while a peak at 500 Hz was due to pressures changes caused by— natural vibration of the straightening plates. Frequency characteristic f' of the pressure PSD and pressure PSD' of the actual equipment are given by the following calculation:

Experimental fluid density $\rho_0=1.22\text{kg/m}^3$ (actual equipment $\rho'=5.67\text{kg/m}^3$), typical speed $V_0=50\text{m/s}$ (actual equipment $V'=60\text{m/s}$), scale ratio $(L'/L_0=3)$. Thus, for Fig. 6, the frequency axis of the actual equipment shall be 0.4 times, while the PSD' axis 112 times. In case of air column resonance, V' is equal to sound speed, sound speed in the air $V_0=350\text{m/s}$, sound speed in steam $V'=502\text{m/s}$, so that the frequency shall be 0.48 times. The air column resonance frequency at 330Hz in Fig.7 was 158Hz for the actual equipment, which is fairly equal to the 1st natural frequency in Fig.3. PSD of the actual equipment converted by the similarity rule are indicated in Fig.8. Values of random excitation components due to vortex are small and similar to those obtained by the first result of LES. Straightening plates of other sites are different in size (w:483, L:1751; w:383, L:1826) from this case, thus the natural frequency and the air column resonance frequency are apart from each other. It is thus estimated that no problem occurred.
