(1) Mechanism of dry friction whip

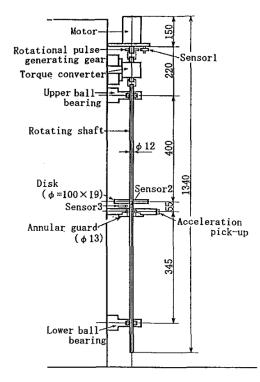
Fig.1 Experimental equipment (reference 1, 2) Rotor in contact with annular guard (center rest)

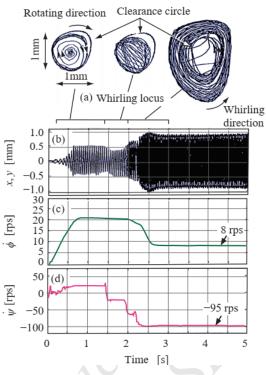
Fig.5 Vibration for amount of mass eccentricity $\varepsilon = 130 \mu m$, No backward vibration occurred (reference 2)
