Chapter 6

Analysis of Traffic and Physical Distribution within the Disaster Areas

Takayoshi KAMADA*

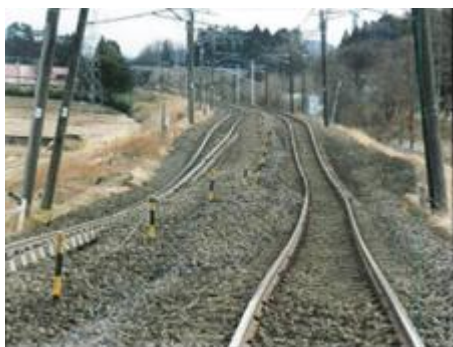
Fig.2 Subsidence of embankment

were remarkable. Numerous damages, such as the misalignment of the rails (Figure 2) and train tracks that were completely destroyed (Figure 3), were seen in the damaged areas. Damages caused by the tsunami were very serious; not only were tracks washed away but 23 stations on seven different lines became unusable. Many trains were forced to stop between stations near the Pacific coast due to the earthquake. The passengers of 27 trains that were in danger of being affected by the tsunami (five of which were actually struck), were able to evacuate before the tsunami arrived.

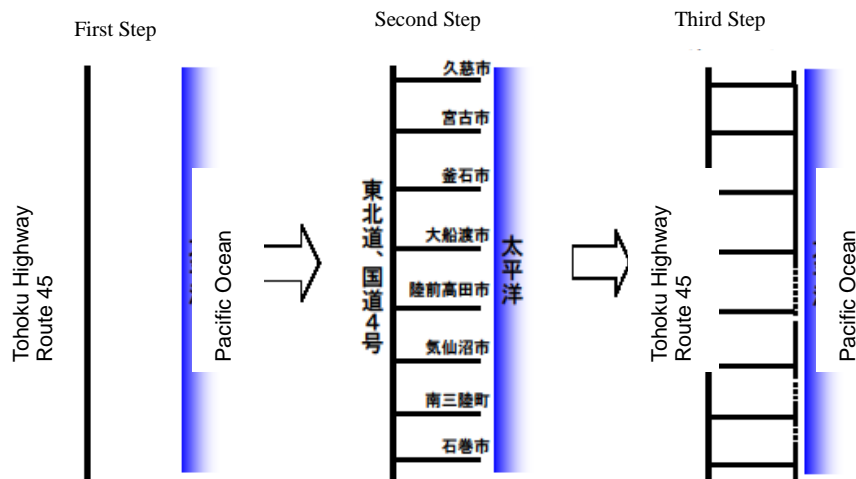
Figure 6 The “Kushinoha Sakusen” (Teeth of Comb operation)

During this earthquake, the “Kushinoha Sakusen” (Teeth of Comb operation) contributed greatly to the quick recovery of the roadways and logistics operations (Tohoku District Transport Bureau, Ministry of Land, Infrastructure, Transport and Tourism, 2013b). Figure 6 shows an outline of the Kushinoha Sakusen. To ensure a quick recovery for the heavily damaged areas near the offshore regions of the Sanriku coast, the

Tohoku Highway and National Road 45, which run north-to-south and were not heavily damaged, were repaired first. Next, the roads that run east-to-west to the coastal areas were repaired. The other roads that ran along the Sanriku coastline were repaired last. These procedures were determined on the day of the earthquake, and 97% of National Road 45 was usable by March 18th.
