# Lessons Learned from the Great East Japan Earthquake Disaster

## Report of the JSME Research Committee on the Great East Japan Earthquake Disaster

The Japan Society of Mechanical Engineers

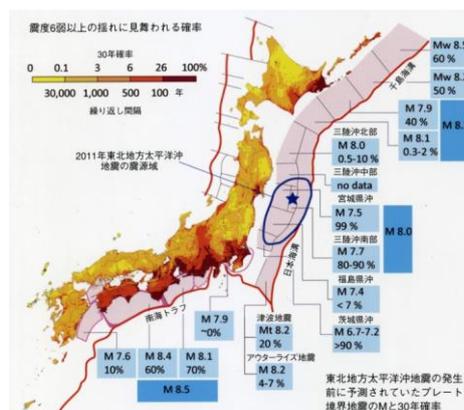
Figure 1. Long-term assessment of subduction earthquakes and National Seismic Hazard Maps (2010 version)

The Earthquake Headquarters has made its long-term forecasts for the source area of the Tohoku Earthquake, using only the historical earthquake activity data for the past 400 years, over which the level of accuracy is at its highest. In principle, it was not possible to forecast subduction earthquakes that exhibit long activity cycles exceeding 400 years. The problem has been known since before the Tohoku Earthquake struck, so investigative research on paleoseismicity and paleotsunamis commenced by examining tsunami deposits in order to extend the period for historical earthquake activity data, but the Tohoku Earthquake occurred before the results were released.

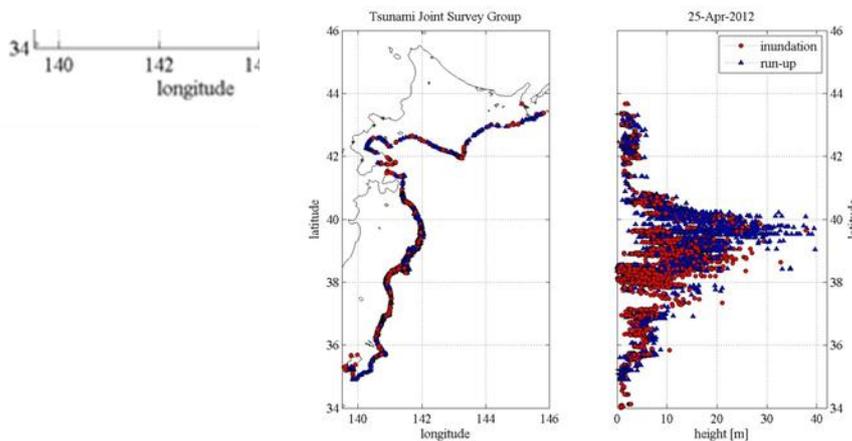
Figure 2. Results of tsunami survey by the Tohoku Earthquake Tsunami Joint Survey Group. Blue triangles indicate run-up height; red circles indicate inundation depth.

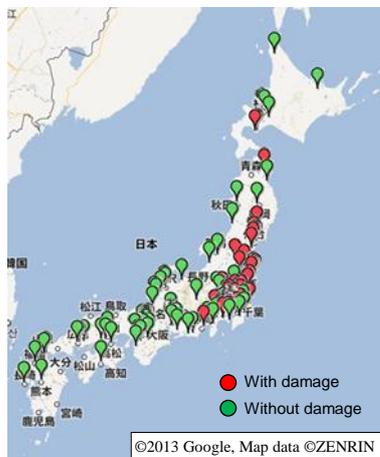
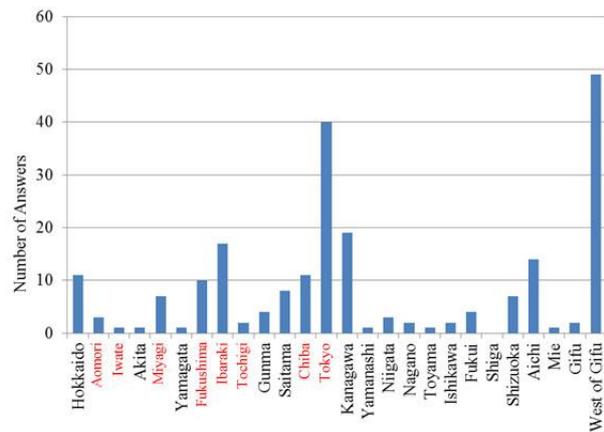
Fig. 1 Results of the JSME questionnaire

(a) Seismic damage distribution for industrial facilities (as of June 15, 2012)

(b) The number of questionnaire responses by region

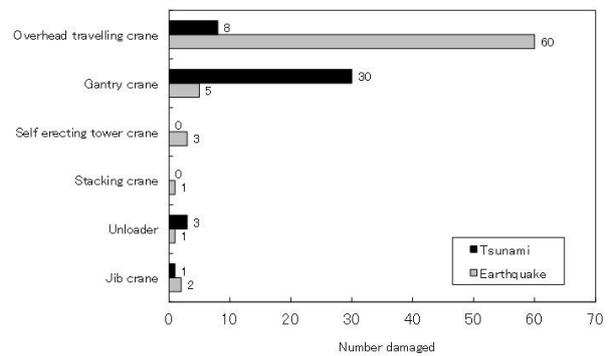
Fig. 11 Number of damaged cranes by type

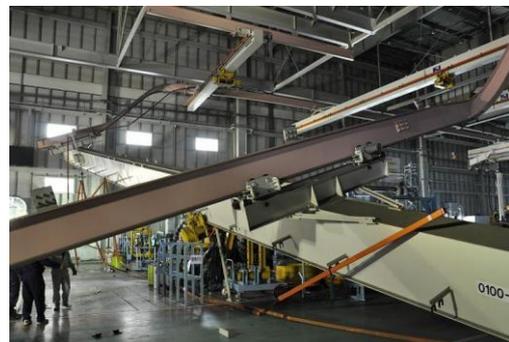
Fig. 13 Failure mode of an overhead crane (fallen rail)

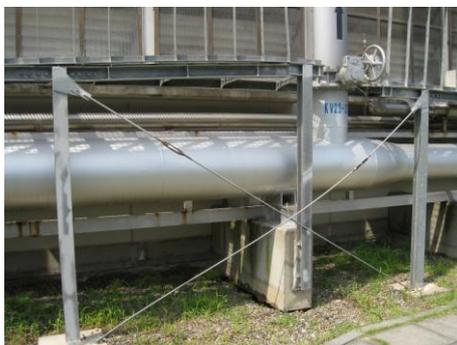
Fig. 16 Uplift of a pipe support base due to ground subsidence

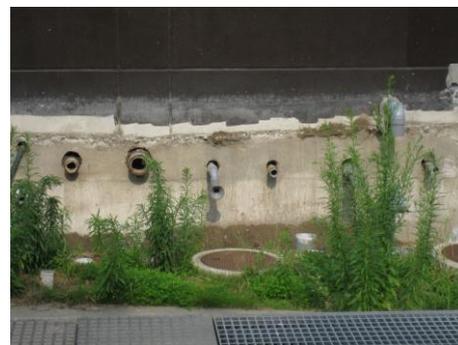
Fig. 17 Pipes fractured at the connection point of the building and soil

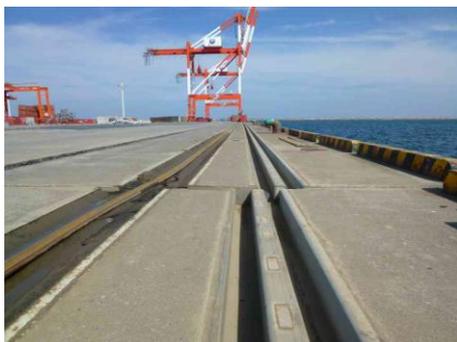
Fig. 18 Quay wall deformation and misalignment of the unloader rail

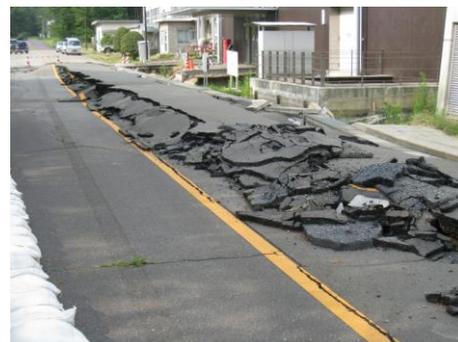
Fig. 19 Damage to road due to ground subsidence

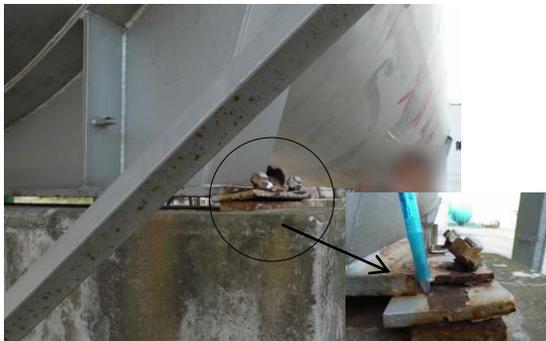
Fig. 20 Lifting damage to LPG tank by tsunami

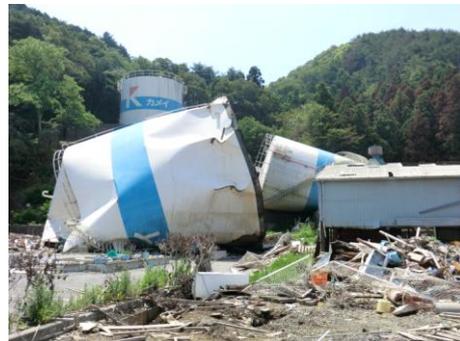
Fig. 21 Tanks washed away by tsunami

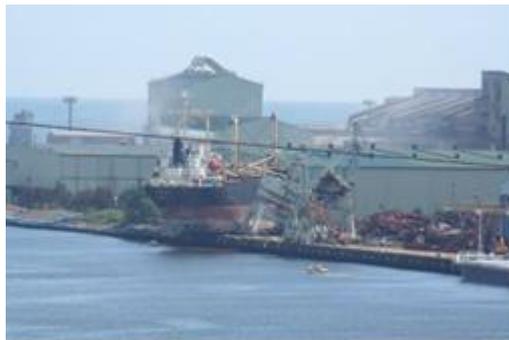
Photo 1 A large ship that was sent crashing into a coastal factory by the huge tsunami following the GEJE (Yahoo! JAPAN, 2011).

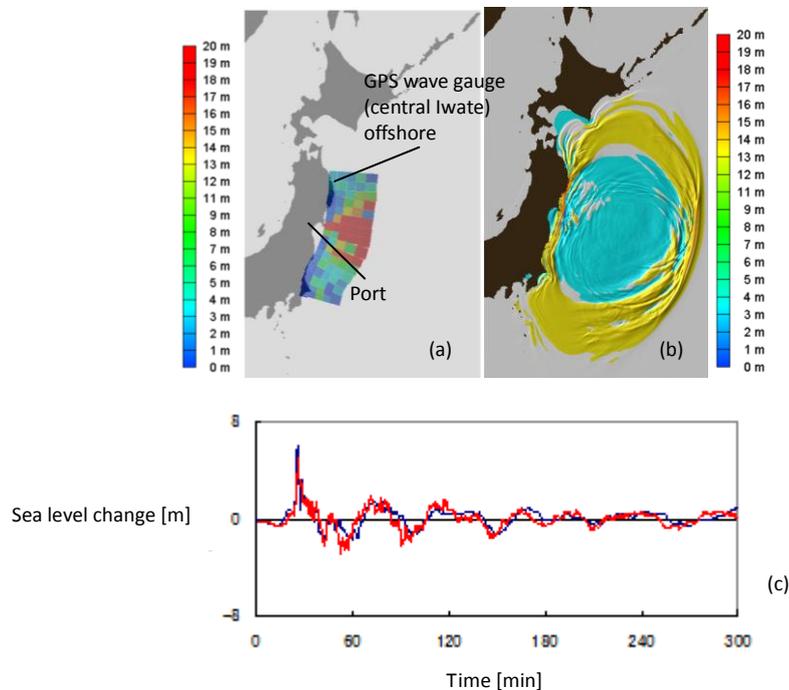
Fig. 2(a) Analysis region of tsunami wave propagation in ocean and tsunami source model, (b) Tsunami sea level distribution at 30 min after the earthquake occurrence, (c) Comparison between observed sea level (blue) and simulation result (red).

Figure 2(b) shows the distribution map of the tsunami sea level at 30 min after the earthquake occurrence. Figure 2(c) shows a comparison of the simulation waveform and GPS wave gauge observation of the Nationwide Ocean Wave information network and HAbourS (NOWPHAS). These waveforms are the raw unfiltered data. The simulation reproduces the observed waveform very well.

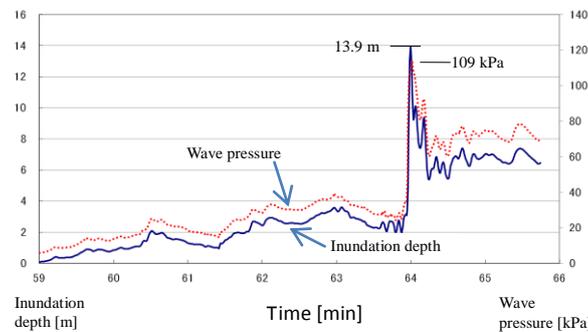
Fig. 7 Calculated time histories of flooding depth and wave pressure at point 1.

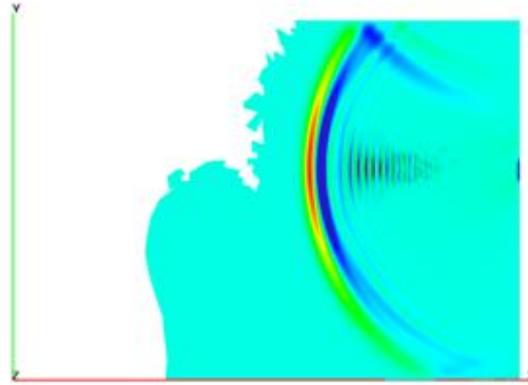
Fig. 8 Simulation of tsunami wave propagation off the coast of Tohoku.

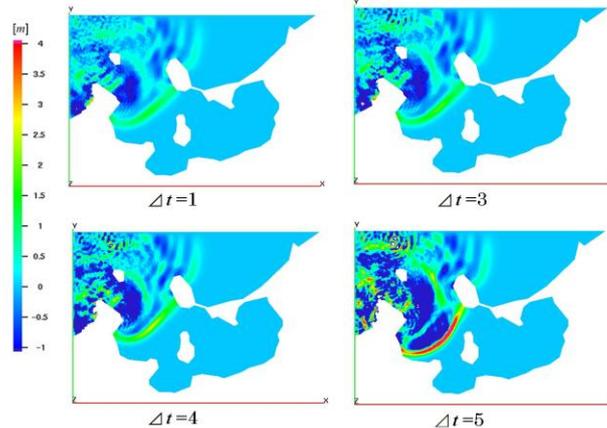
Fig. 9 Simulation results in Hakata Bay.

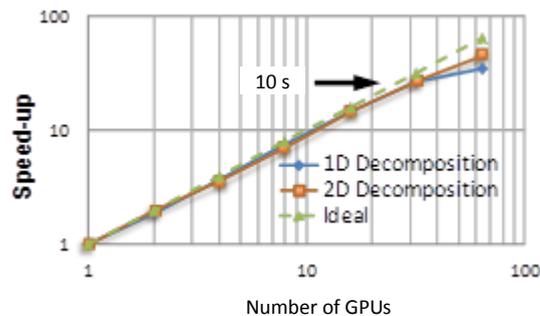
Fig. 11 Speed-up of computation time of tsunami propagation simulation for the number of GPUs.

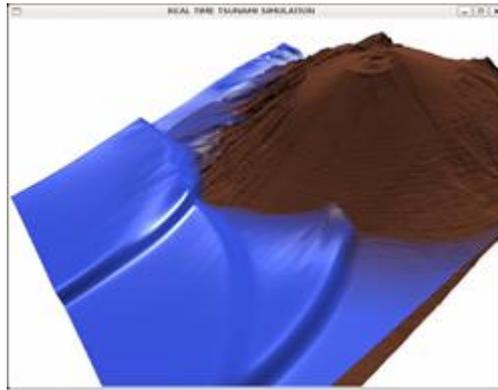
Fig. 12 GPU-based real-time simulation of tsunami propagation with run-up.

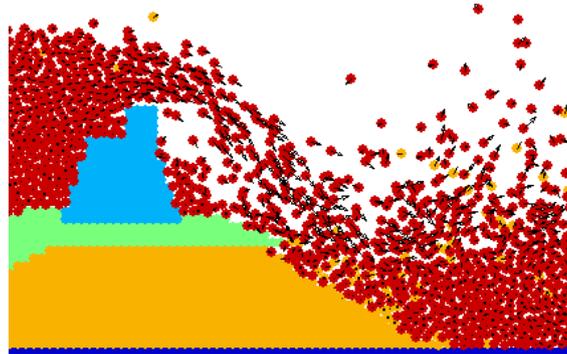
Fig. 22 Ground collapse by jet flow over levee.

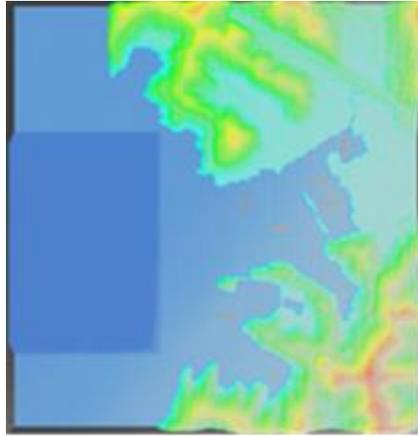
Fig. 25 Initial condition of fluid-rigid body interaction simulation.

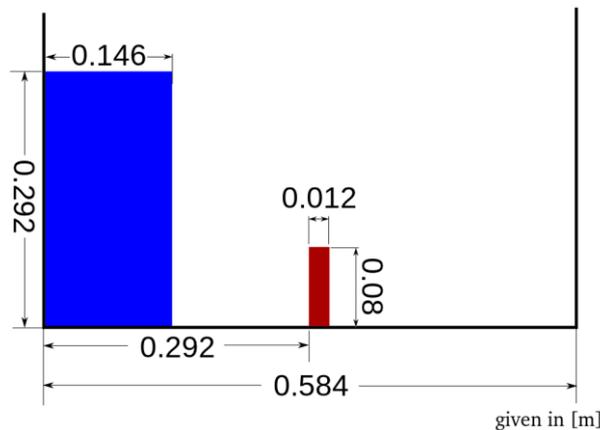
Fig. 28 Analysis setting of dam break problem with elastic obstacle.

Figure 29 shows the time history of displacement of the top edge of the elastic wall in the x direction. Figure 30 shows several snapshots of the simulation results. Figure 29 shows a comparison of the present simulation results with other results (Walhorn, et al., 2005, Ryzhakov, et al., 2010). The time to collide and the peak value of the displacement of the MPS-FE method coincide well with the results of the particle FEM.

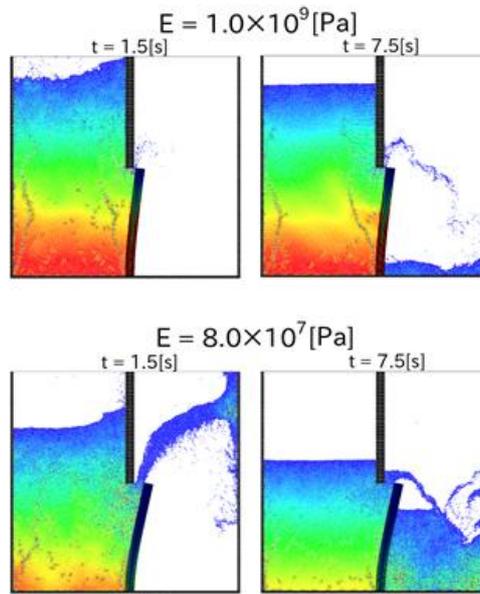
Fig. 31 Fluid invading simulation.

Next, we performed a simulation of water-invasion right after the deformation of the elastic wall. Figure 31 shows the simulation results (Mitsume, et al., 2014). As for buildings containing important machines, their structure is built to be very strong, and furthermore water-tight doors might be equipped. In such cases, even though the structure itself is not destroyed and damaged, the water-tight door might be deformed by impulsive water pressure, and consequently water may enter the building causing damage to important machines. Therefore, this kind of simulation is very important to quantitatively evaluate the practical performance of water-tight doors.

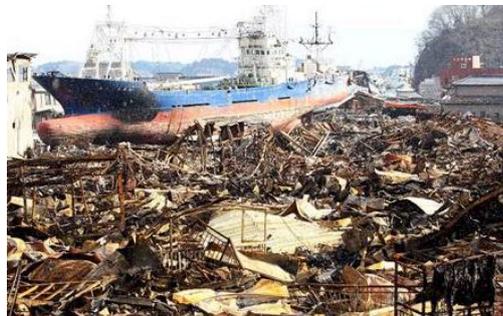
Photo 2 A ship washed up by the tsunami (Sankei Digital News, 2011).

The giant tsunami that occurred after the GEJE carried debris such as ships and cars upstream and caused additional damage to buildings in the area. For example, some buildings were irreversibly damaged, even though they were placed higher than the tsunami trace in Kesen-numa City, Miyagi Prefecture, as shown in Photo 2. It is thought that this damage resulted from large tsunami debris such as ships that were originally moored in the harbor (PARI, 2011b). The wave height of the tsunami that reached Kesen-numa harbor was approximately 6 m. Supposing that the wave velocity was 6–7 m/s, the force generated by the giant tsunami can be estimated as approximately 10 ton/m<sup>2</sup>, which is sufficient to completely destroy buildings (NIRIM, 2011).

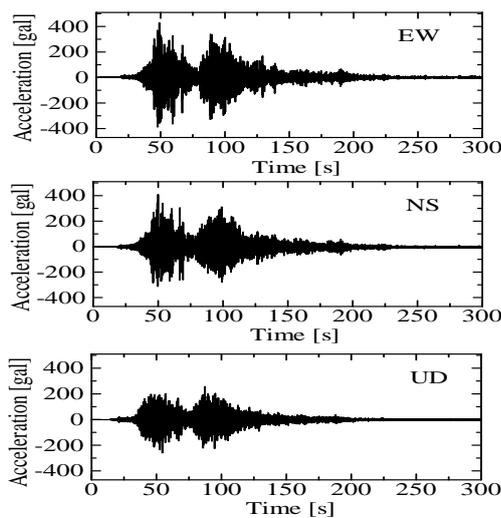
Fig. 32 Seismic wave observed in Kesen-numa City. (Data from 0–150 s is used as input.)

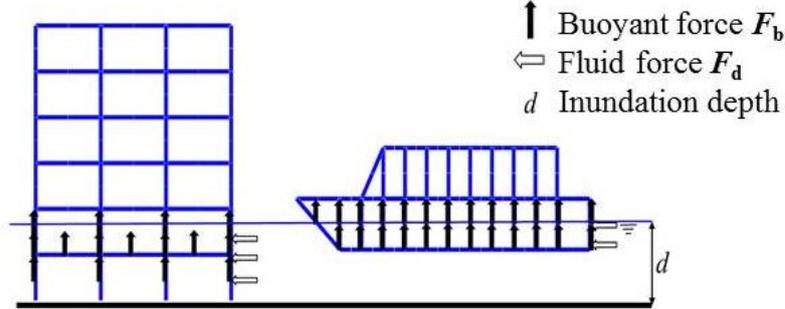
Fig. 33 Fluid force and buoyant force subjected to the building and tsunami debris.

force dynamically to the building and debris models, as shown in Fig. 33. The fluid force is calculated by assuming the maximum run-up height of the tsunami as  $R^* = 21$  m and the tsunami height as  $h = 15$  m, based on the data observed in Kesen-numa City (City of Sendai, 2012). Two building models are investigated, built at 9 m and 11 m above sea level.

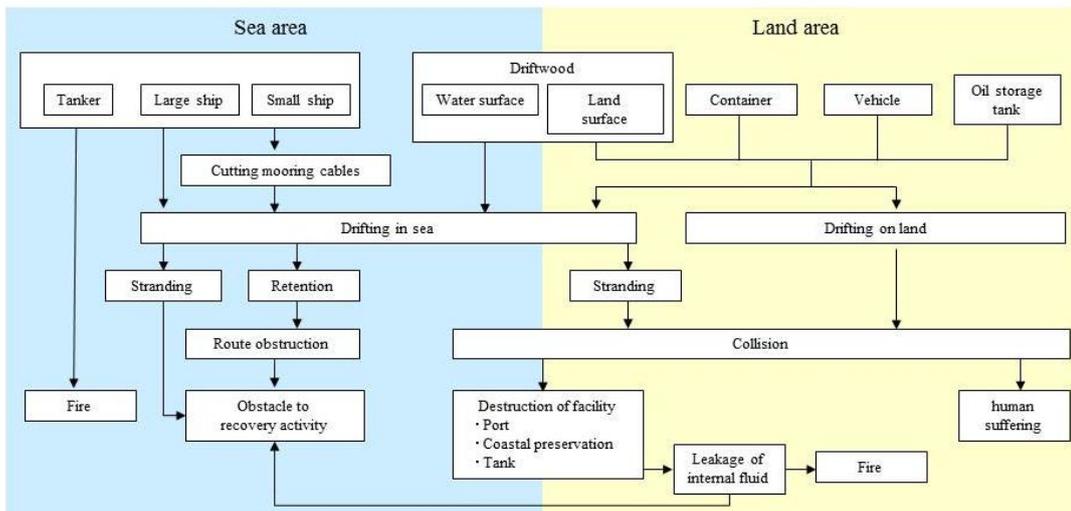
Fig. 37 Disaster scenario according to drifting bodies.

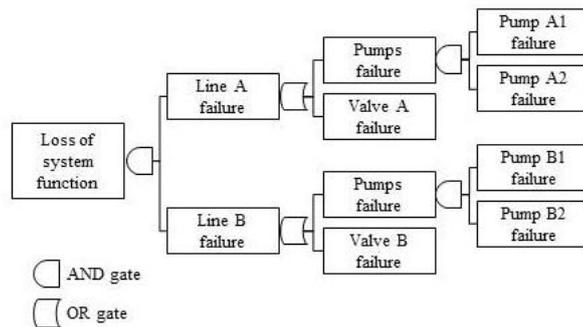
Fig. 38 Example of fault tree.

are deployed to lower-level events until they are broken down to basic events, the failures of which can be evaluated directly. An example of the fault tree is shown in Fig. 38. All lower-level events are connected to upper-level events via an "AND gate", which means that an upper-level event occurs when all lower-level events occur, or an "OR gate", which means that an upper-level event occurs when at least one lower-level event occurs. In the case of the usual FTA, the top event probability is calculated from the fault tree and an individual basic event probability corresponding to the failure rate of each device. However, in the case of such events as tsunamis, they are very rare but cause significant damage. Therefore, applications of the conventional methods may not be sufficient. In reverse, it is appropriate to enumerate all conditions that cause the top event, to clarify the causal relationship between the loss in the whole system and external force due to tsunamis (such as wave power, buoyancy, impact force by debris) and inundation applied to the facilities and equipment, and to efficiently plan disaster prevention and mitigation based on those analyses. However, in the case of huge complex systems, such as industrial plants, it is not practical to break down into individual components and discuss their failure rate one by one. In order to realize the above-mentioned analyses in the future, it is necessary to clarify the relationship between tsunamis and the loss of function of the equipment with a batch of certain degrees.

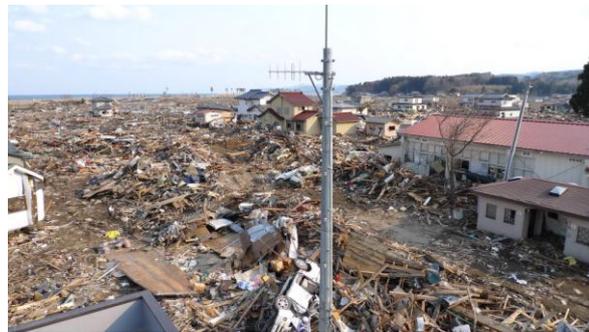
(b) Noda-mura

Fig.2 Damages in the northern areas of the Sanriku coast

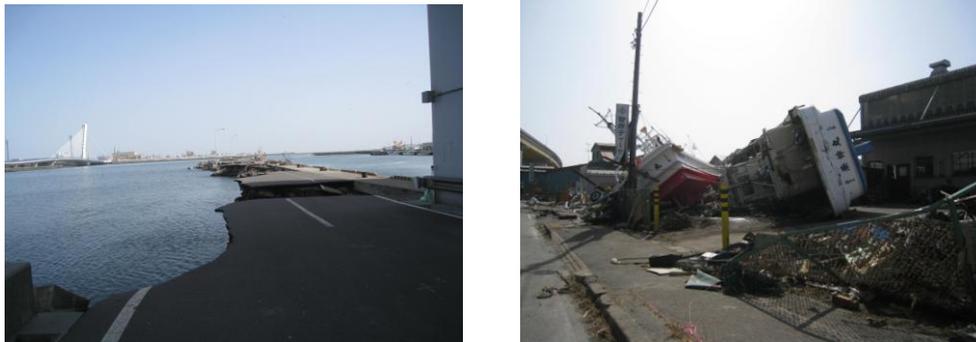
Fig.3 Damages to Hachinohe port

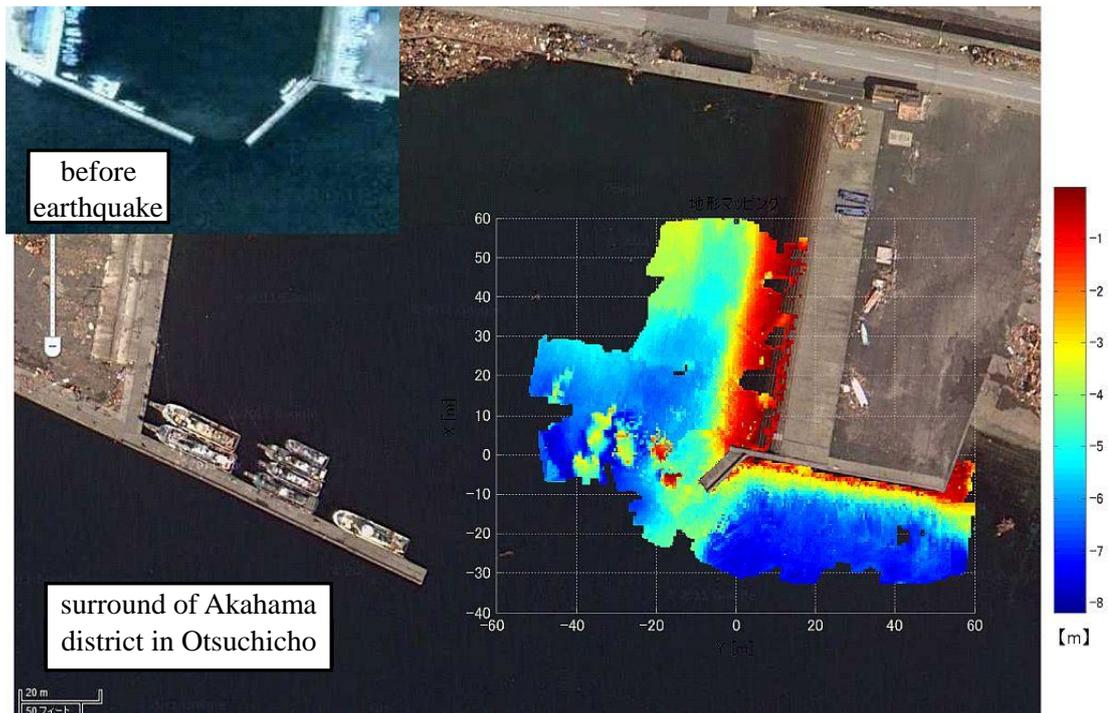
Fig.8 Bathymetry data obtained by the ASV. A photo of the area prior to the tsunami is shown in the top-left. Photos are from Google Earth (<http://www.google.co.jp/intl/ja/earth/index.html>).

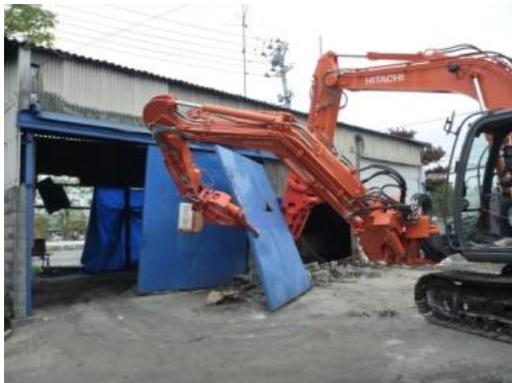
(a) Removing the doors of a damaged warehouse

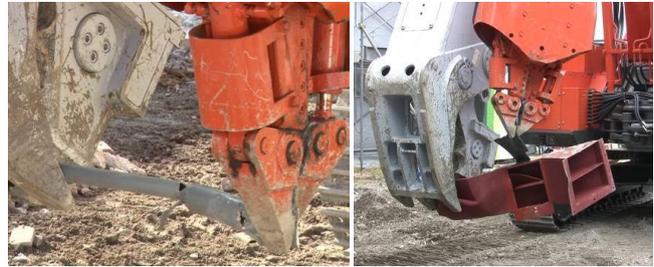
(b) Newly developed multifunctional hand

of the Sanriku coast during May and June 2011. ASTACO NEO was developed during a project that was sponsored by the New Energy and Industrial Technology Development Organization (NEDO) (Yanagihara et al., 2009). One arm operates as the main arm that can be attached with commercial tools, such as 11-ton hydraulic shovels, and the other is a sub arm that can be attached with the newly developed versatile hand shown in Fig.10(b), which can grasp small objects at its finger tips and cut reinforcing steel at the base of its fingers. The degrees-of-freedom of the main arm is 5 and that of the sub arm is 9, both of which include their attachments. The main arm is controlled by the joystick on the right side and the sub arm is controlled by the joystick on the left side. The operations applied to the machine were completed smoothly and the robot was verified to have high efficiency. As another robotic technology, Smart Suit Light, which is a passive powered suit developed by Prof. Tanaka of Hokkaido University, was used to reduce the loads of the workers when removing debris (Imamura et al., 2011).

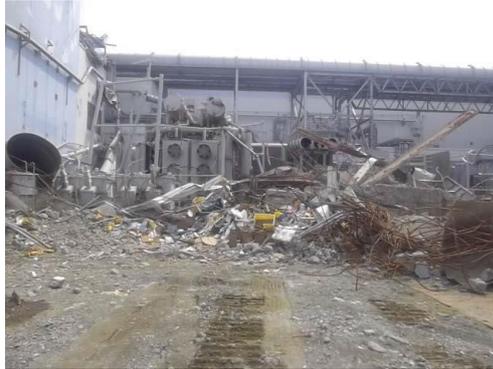
Fig.11 Debris that was scattered due to the hydrogen explosions

The hydrogen explosions of nuclear power units 1–4 affected a very wide area. Light debris was scattered along the road surrounding the power plant far from the buildings. Pieces of radioactive debris varying in size were also piled on top of cars and trailers around the reactor and turbine buildings, which disturbed the access of fire-extinguishing vehicles or concrete pumping tracks to the reactor buildings (Fig.11). Moreover, since it was strictly prohibited for workers to enter the buildings due to the high radioactivity, the amount of damage within the buildings was unknown. To recover from such an accident, it is essential to access the buildings and investigate the amount and type of damage; therefore, the development of many types of tele-operated robotic systems was urgently needed. However, there was no such robot in Japan applicable to the Fukushima Daiichi NNP immediately after the accident due to the unexpected severity of the accident. From the beginning of April 2011, unmanned construction technologies that were developed in Japan were used for the removal of radioactive debris outside of the buildings, which resulted in not only a clear accessible path to the buildings, but also a decrease in the level of airborne radiation. In April 2011, some U.S. military robots were modified for the Fukushima Daiichi NNP accident and were used to monitor the airborne radiation and to investigate the severity of damage. In June 2011, a Japanese rescue robot was utilized to investigate the interior of the reactor buildings. Currently, many robots have been developed in Japan and being used to remove debris, to monitor radioactivity or other physical parameters, and to inspect the damage to the nuclear reactors and buildings. Many more robot technologies related to the construction machines or rescue systems will be developed and used for the required tasks to decommission nuclear power units 1–4.

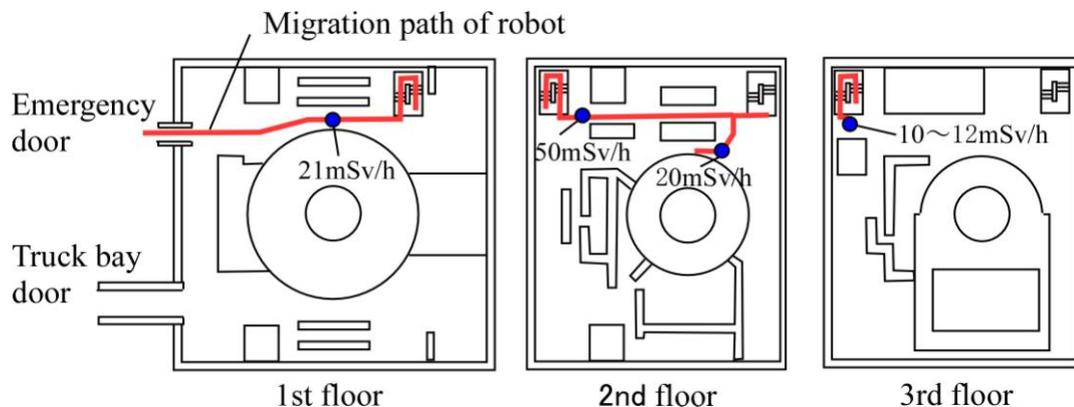
Fig.22 Root for inspecting the damage in reactor building 2 on 8 July 2011

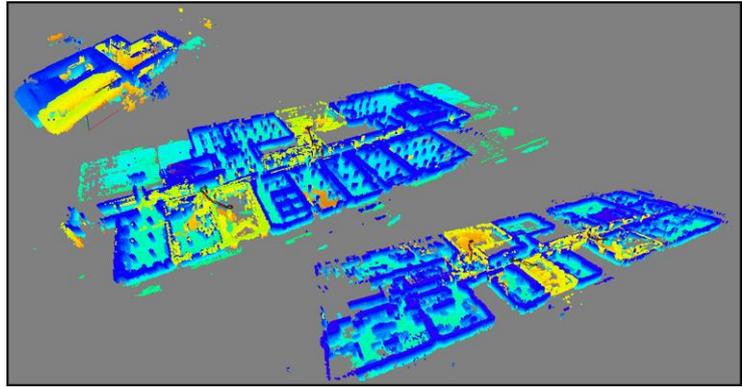
Fig.23 Inspection of a damaged building conducted in collaboration with Quince, Pelican, and Kenaf

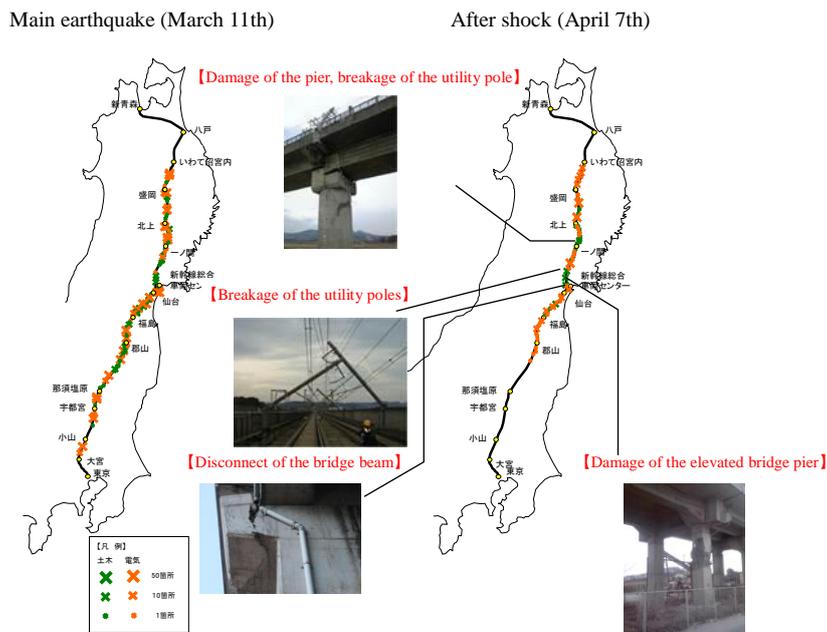
Fig.1 Damage of Tohoku Shinkansen line

The local lines of the JR East Company were directly affected by both the earthquakes and tsunami; however, the Shinkansen lines were not affected by the tsunami. The damages to the electricity columns

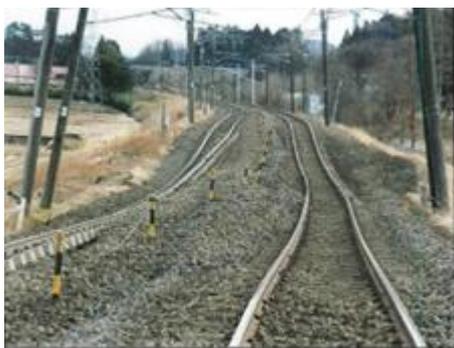
Fig.2 Subsidence of embankment

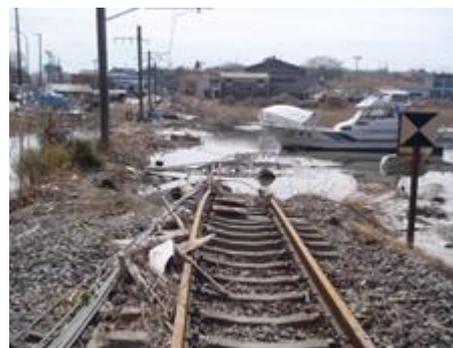
Fig.3 Washed away of track

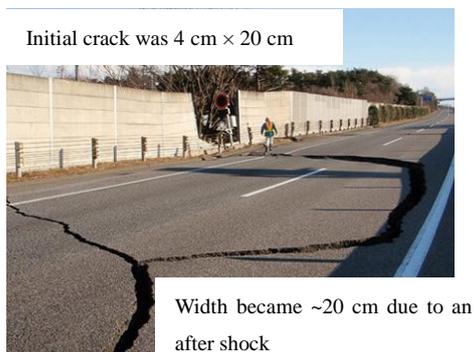
Figure 4 Cracks that formed in a road

As for normal roads, National Road 45, which is located along the Sanriku coastline, was severely damaged. Numerous cracks formed, some areas of the road were covered with water, and some bridges were washed away by the tsunami. Numerous damages such as cracks, fallen stones, and subsidence appeared on the other national roads.

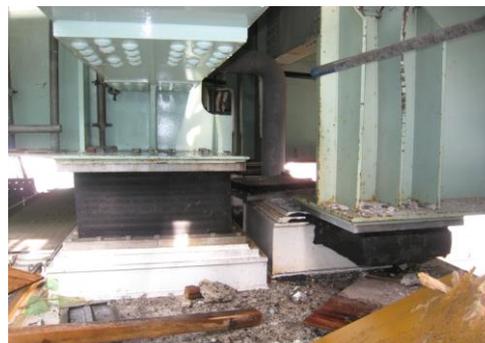
Figure 5 Damage to a bridge support

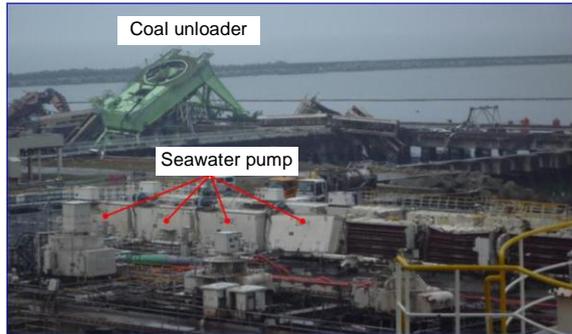
(a) Damaged coal unloader and sea water pump.

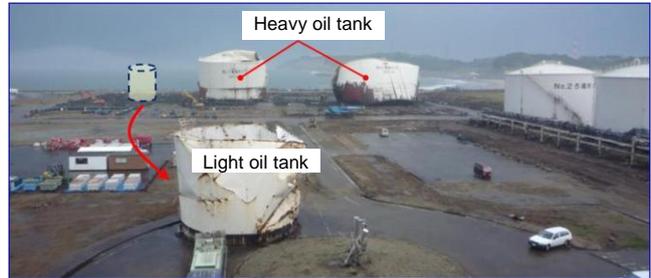
(b) Damaged light and heavy oil tanks.

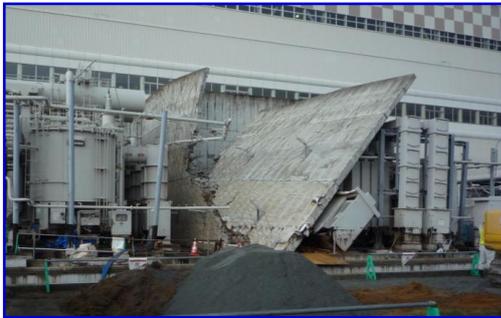
(c) Damaged concrete wall.

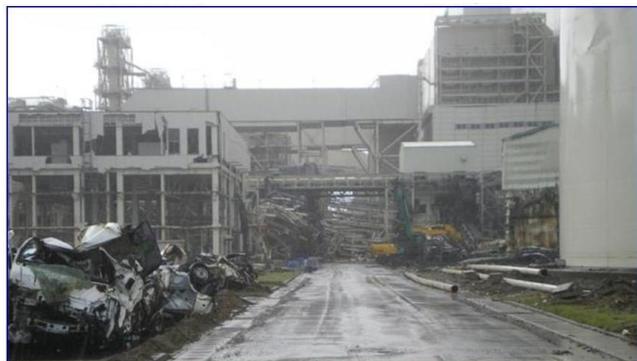
(d) Damages to unit #1.

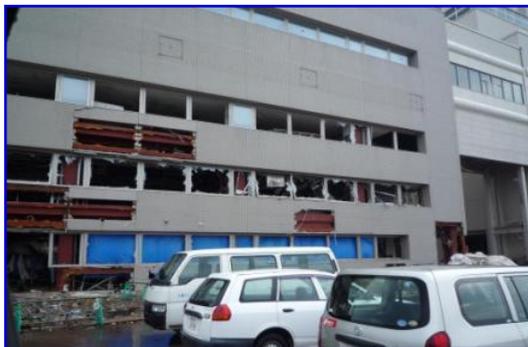
(i) Wall facing the sea.

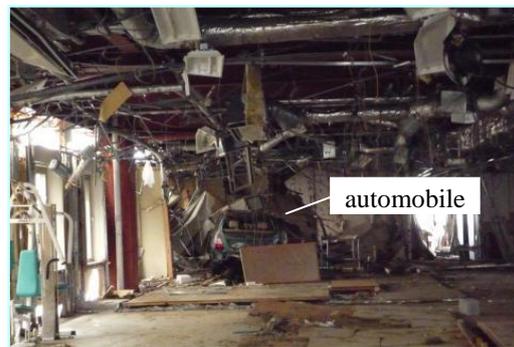
(ii) The 2nd floor.

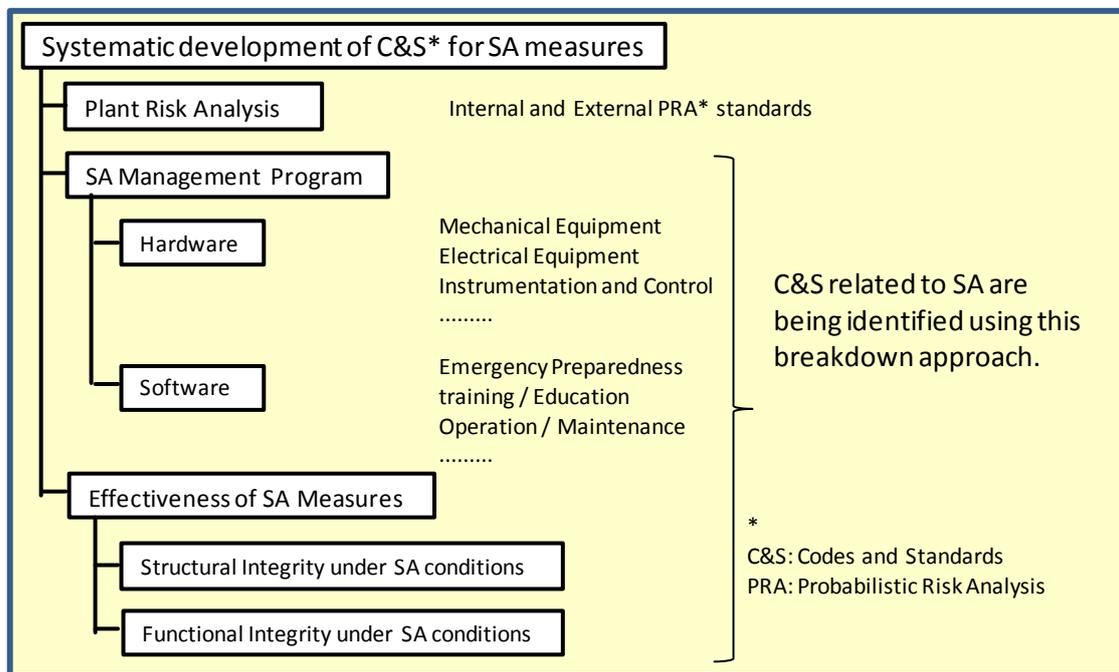
Fig. 2 Systematic development of codes and standards for SA measures

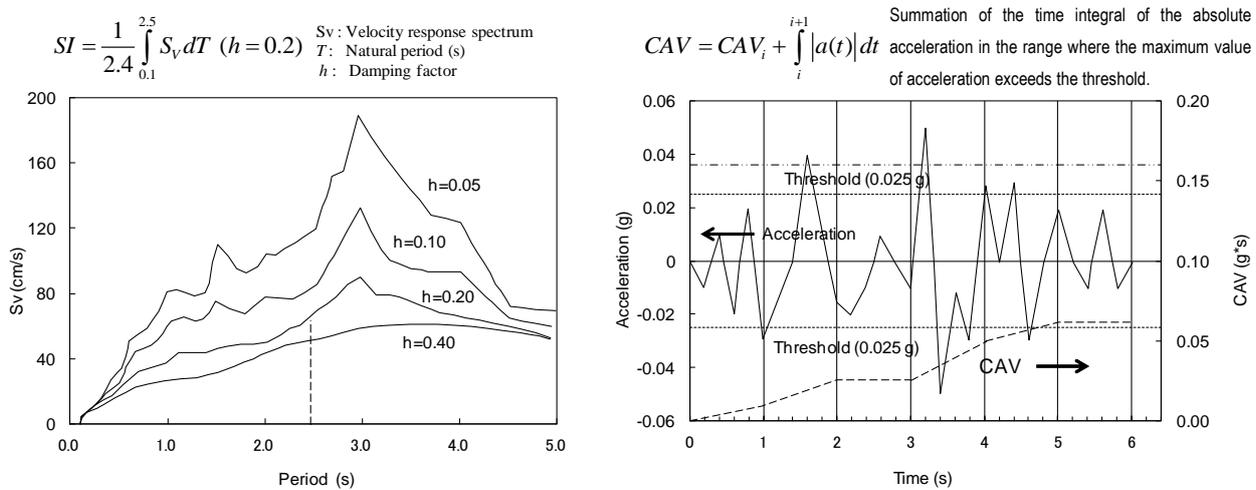
Fig. 4 Definitions of the (a) SI value and (b) CAV

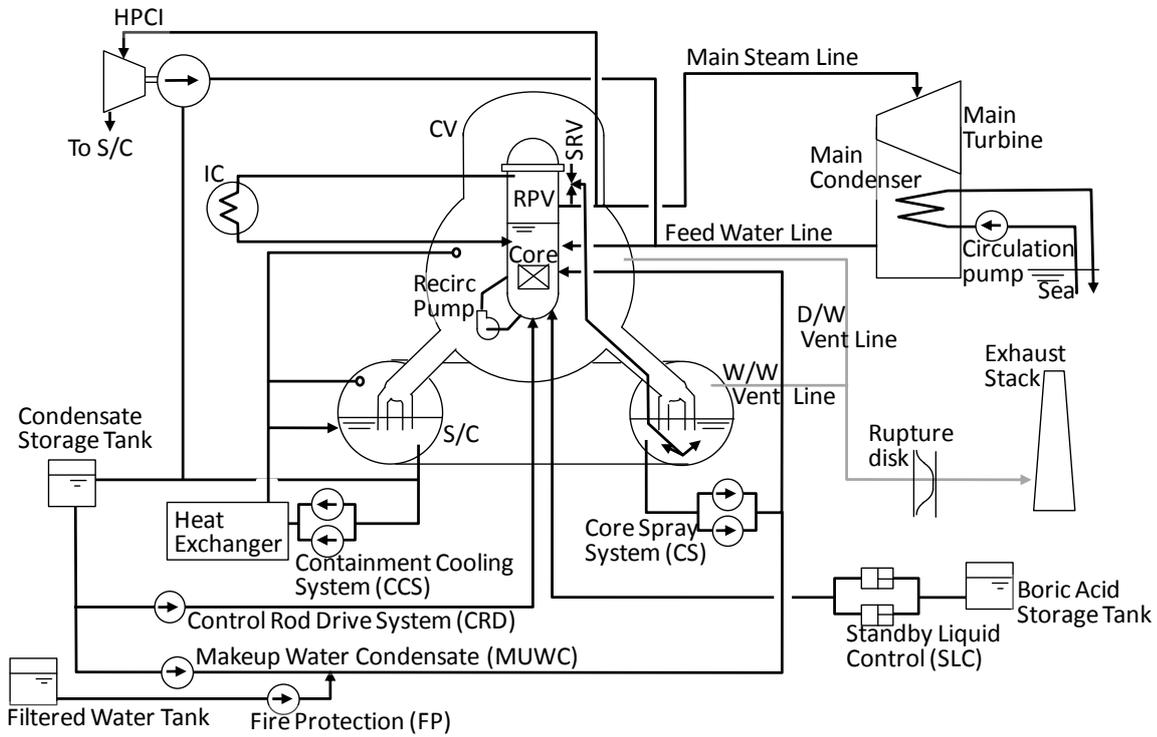
Fig.1 Outline of the primary equipment of unit 1 of the Fukushima Daiichi NPP.
