Chapter 3

Damage to Machines and Equipment, and Good Practices for Seismic Countermeasures

Report of the JSME Research Committee on the Great East Japan Earthquake Disaster

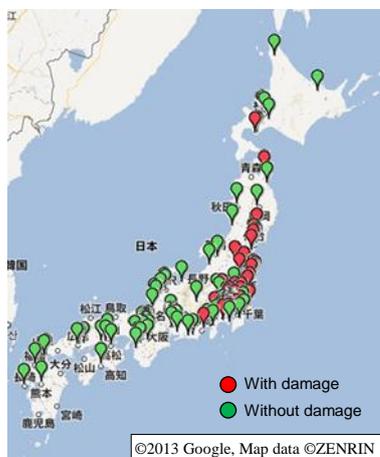
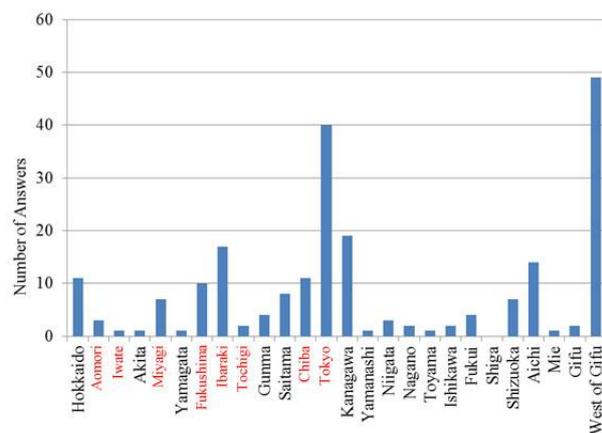
Fig. 1 Results of the JSME questionnaire

The JSME distributed a questionnaire to investigate the influence of the earthquake on industrial facilities about two months after the earthquake. The questionnaire was sent to about 1,000 organizations, and around 200 of them responded. Figure 1(a) shows a map of Japan and the questionnaire answers, and Fig. 1(b) shows the number of questionnaire answers for each prefecture. In Fig. 1 (a), the red marks denote damaged facilities and the green marks denote facilities that did not sustain damage. In Fig. 1 (b), the prefectures shown in red characters were the "disaster-stricken regions" where the Disaster Relief Act was applied. Although the questionnaire responses were mainly from the Kanto region and the numbers of answers obtained from the seriously tsunami-damaged areas in Iwate, Miyagi, and Fukushima were relatively small, some features of the seismic damage caused by the GEJE and other important knowledge was obtained from the various answers.

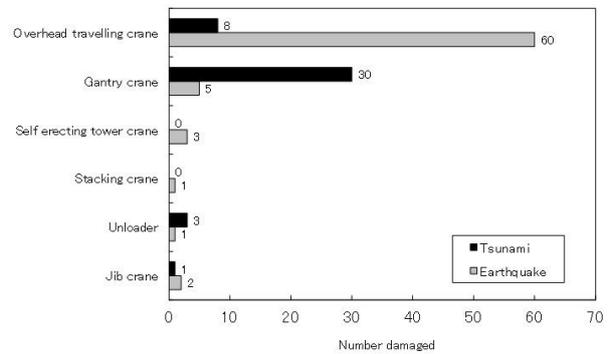
Fig. 11 Number of damaged cranes by type

Cranes and unloaders were also damaged by the earthquake and damage investigations were conducted by the Japan Crane Association (JCA) (Japan Crane Association, 2011). Figure 11 shows the number of damaged cranes with respect to crane type, revealing that it was mainly overhead cranes that were damaged by the seismic motion. Figure 12 shows a typical failure of an overhead crane. The hook bolts that held the crane rail deformed or fractured. Figure 13 shows another failure mode of an overhead crane. The failure occurred at the welding point at the suspension of the crane rail.

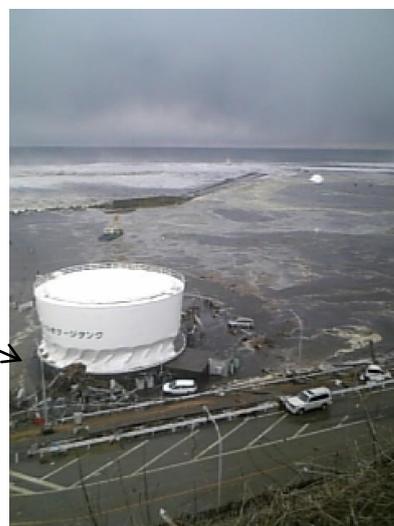
Fig. 24 Damage due to collisions with floating objects (Provided by TEPCO)

in Fig. 24 (Japan Crane Association, 2011). This container crane had an isolation system at the bottom and was not damaged by the seismic motion. However, wreckage hit the cover of the device and deformed it. Salt damage also occurred due to tidewater flooding. In many cases, electrical systems and devices including power panels required inspection, cleaning, and replacement after the tsunami. In addition, the large amount of rubble left after the tsunami hindered the disaster-relief at industrial facilities (Thermal and Nuclear Power Engineering Society, 2011). The tsunami affected near-sea level facilities, but no damage was sustained by elevated sites. Thus, it is effective to install essential equipment in elevated areas.
