Chapter 5

Application of Robot Technologies to the Disaster Sites

Hisashi OSUMI*

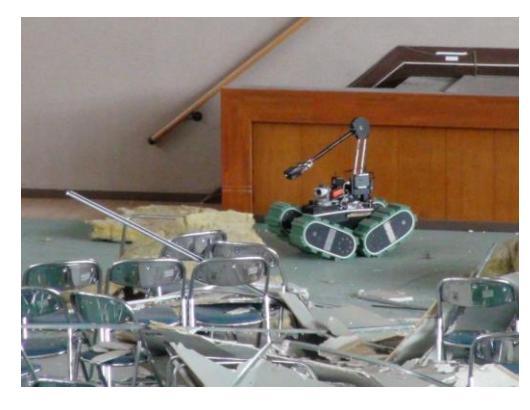
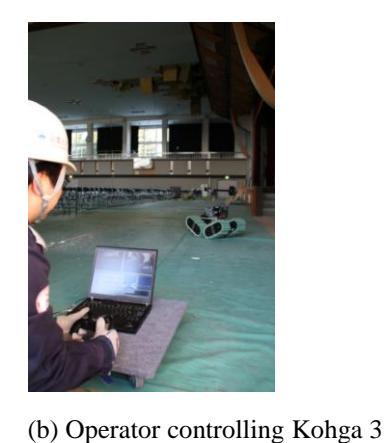
(a) Kohga 3 in the gymnasium (b) Op Fig.1 Kohga 3 inspecting the gymnasium

The area devastated by the tsunami disaster was extensive and the amount of damage was unknown to the people in the other regions of Japan. The first robot activity that was employed at a tsunami disaster site began at a gymnasium that was in danger of collapsing seven days after the earthquake in Hachinohe. Prof. Matsuno from Kyoto University and his colleagues entered the disaster site from the northern part of the Sanriku coast on 18 March 2011 and tele-operated their developed mobile rescue robot "Kohga 3" to inspect the damage of the gymnasium, as shown in Fig.1. However, it was revealed that their robot was not able to locate survivors (Fig.2). On the other hand, it was revealed by their interview that the local governments along the Sanriku coast wanted an underwater investigation, since most of the victims died due to drowning. The local governments also wanted to conduct an underwater inspection of the damaged infrastructures and to investigate the amount of debris on the bottom surface of the harbors in order to ensure a prompt reconstruction of the damaged fishing harbors (Fig.3). Following a report by Prof. Matsuno on the robot activities and the investigation of the damage along the Sanriku coast, the Center for Robot-Assisted Search and Rescue (CRASAR) and International Rescue System Institute (IRS) collaborated and established a team to organize the operations for an underwater inspection. The operations began 18 April 2011 along the Sanriku coast. Prof. Hirose from the Tokyo Institute of Technology also began an underwater search for victims in the southern part of the Tohoku area on 19 April 2011. At the beginning of May 2011, the University of Tokyo Ocean Alliance and Mitsui Engineering & Shipbuilding Co., Ltd., surveilled the bottom surface of Otsuchi bay and found two victims. In the towns devastated by a tsunami, the new construction machine "ASTACO NEO", with twin hydraulic arms, developed by Hitachi Construction Machinery Co., Ltd., were employed to remove debris.

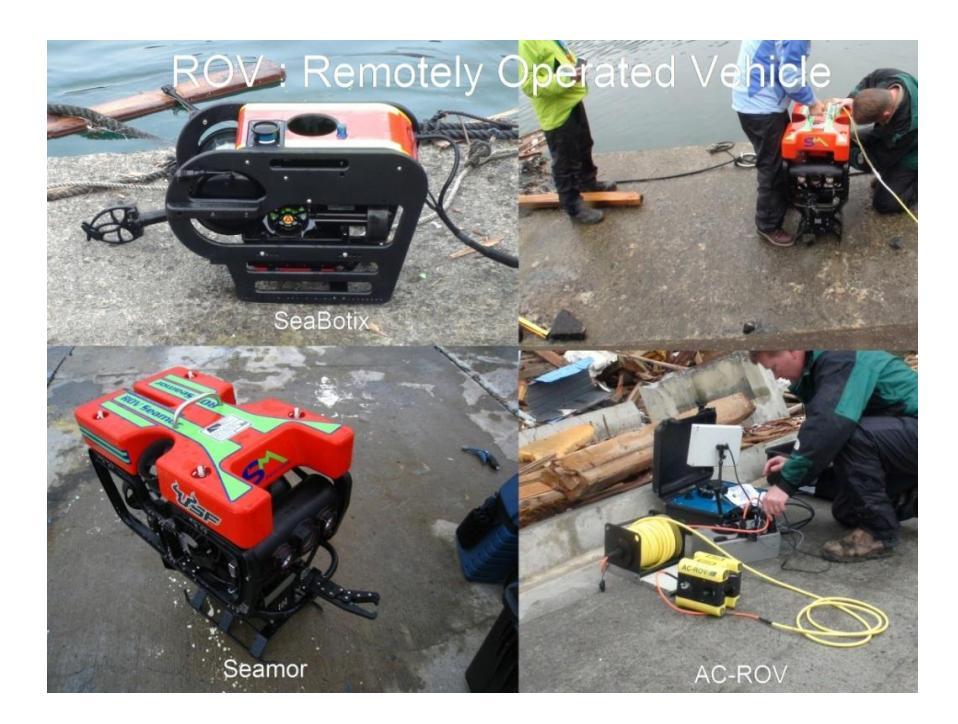
Fig.4 Remotely operated vehicles (ROVs) that were used for the activities Table 1 Specifications of the remotely operated vehicles (ROVs)

ROV	size	weight	tether	sensors	gripper	velocity
	(mm)	(kg)	length (m)			(m/s)
SARbot	549×250×268	17.4	150	camera, sonar, GPS	0	3
Seamor	355×472×335	20	150	camera, sonar	0	3
AC-ROV	204×151×146	3	50	camera	×	1

The ROVs that were used and their specifications are shown in Fig.4 and Table 1, respectively. SARbot is a commercial underwater vehicle developed by SeaBotix Inc. and was mainly used due to its portability and rapid setup/deployment. It is equipped with an enhanced color video camera, the Tritech Gemini 720i multibeam imaging sonar, an accurate GPS system, and a limb grasping mechanism. Seamor ROV was developed by Seamor Marine Ltd., and is equipped with high-resolution sonar and a grasper. AC-ROB is a small robot driven by a battery and captures video. It is similar to a thruster with a video camera and was mainly used to investigate tight places, such as under floating houses. In Minamisanrikucho, SARbot and Seamor were used to check if obstacles were present within 5 m of the water surface in the newly constructed area of the Minamisanrikucho fishing port. Since the clearness of the water was very poor (30-50 cm), a sonar sensor was used to locate large obstacles. As a result, there were no obstacles in the area that was checked. The amount of time that SARbot was in the water was 17 min on 19 April 2011 and 268 min on 20 April 2011, and that of Seamor was 178 min on 20 April 2011. In Rikuzentakata, SARbot, Seamor ROV and AC-ROB were used to search for victims. Since victims were assumed to be trapped by floating debris, as shown in Fig.5, the investigation was conducted under the floating debris or around the heaps of debris where divers had not yet searched. Such locations were very dangerous for divers due to the presence of hazardous materials in the debris, which also made the use of robots essential for the searches. No victims were discovered during these activities. The amount of time that SARbot was in the water was 193 min on 21 April 2011, 97 min on 22 April 2011, and 44 min on 23 April 2011, that of Seamor was 42 min on 22 April 2011, and that of AC-ROB was 35 min on 21 April 2011 and 20 min on 22 April 2011.

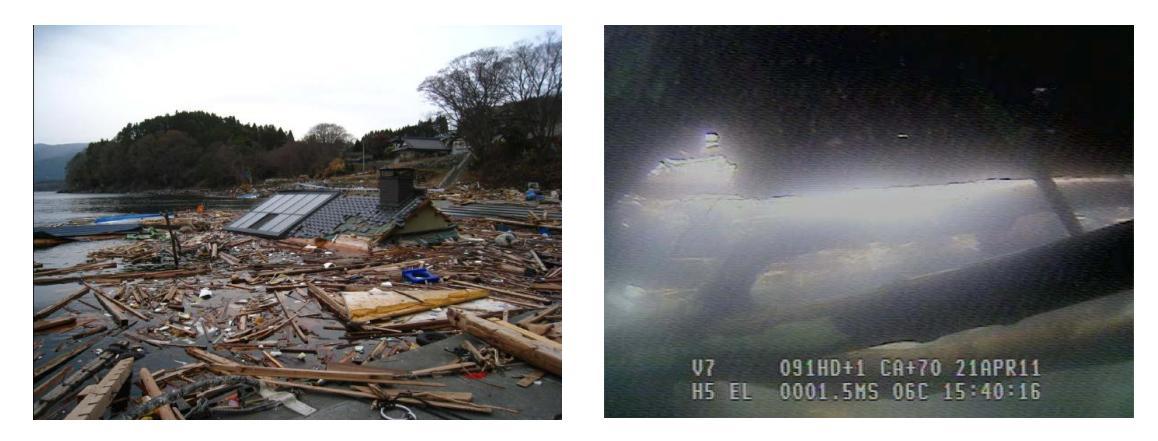
(a) Floating debris driven by tsunami(b) Image captured by the ROV under floating debrisFig.5 Situation of floating debris

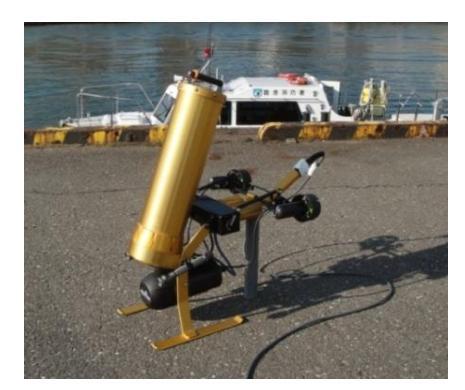
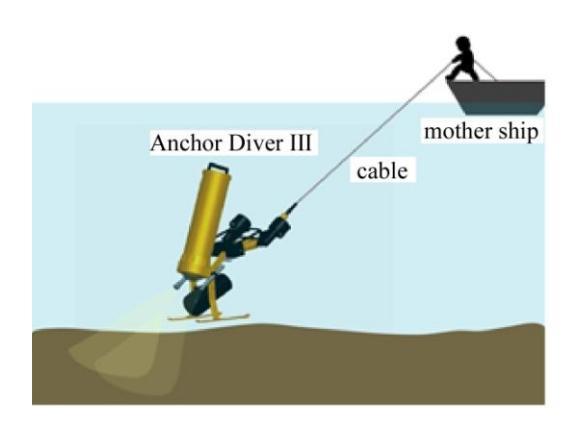
(a) Photograph of Anchor Diver III

⁽b) Operation of Anchor Diver III Fig.6 Anchor Diver III

Anchor Diver III, which is shown in Fig.6(a), was developed for the rescue activities of the Tokyo Fire Department by Prof. Hirose from the Tokyo Institute of Technology. It is equipped with a high-resolution video camera and 2D sonar, and driven by two thrusters. Anchor Diver III is connected to the operation site by a cable and can maintain its own position in tidal streams via the cable tension and thruster control, as shown in

Fig.6(b). Since the direction of the thruster can be changed in the horizontal and vertical directions, the robot can move forward, upward, downward, and to the right and left, but the cable has to be rewound by the operator when the robot moves backwards. The shape of its main body is a cylinder, which is heavy at one end and light at the other. Therefore, the body always has a vertical orientation when in water. A sonar sensor and a camera are equipped on the heavy end of the body (the bottom end) and can continuously measure the bottom surface of the sea. Anchor diver III investigated an area of about 100 m² during a two day period. No victims were found during the investigation, but the conditions of the bottom surfaces of the ports were made clear.

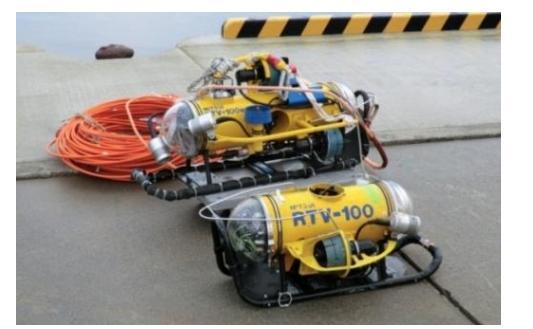
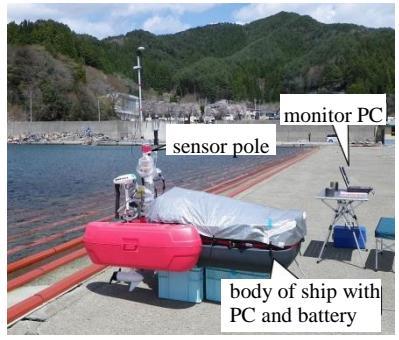
(b) ASV

(a) Remotely operated vehicles RTV-100 and RTV-100Mk2

Fig.7 RTV-100, RTV-100Mk2, and ASV

The University of Tokyo Ocean Alliance investigated the bottom surface of Otsuchi bay and Shizukawa bay in collaboration with Mitsui Engineering & Shipbuilding Co., Ltd., from 28 April to 2 May and 14–19 May 2011, and found two victims. In Otsuchi bay, two remotely operated underwater vehicles (RTV-100 and RTV-100Mk2) and one autonomous surface vehicle (ASV), shown in Fig.7, were used. The length of the ASV was 2.1 m. The ASV can create maps of the sea bottom by using a GPS and its multibeam sonar. It can be autonomously controlled along a predetermined target path via its embedded computer. However, the ASV was not autonomously but remotely operated via a wireless LAN due to troubles with a controller. The map that was obtained is shown in Fig.8. An investigation by two ROVs was also conducted from a fish boat and it was found that a majority of the bottom surface was flat and that there was little debris. Two victims were also found. In Minamisanrikucho, only an RTV was used. The length of surveillance was about 12 hours and 14 locations were investigated.

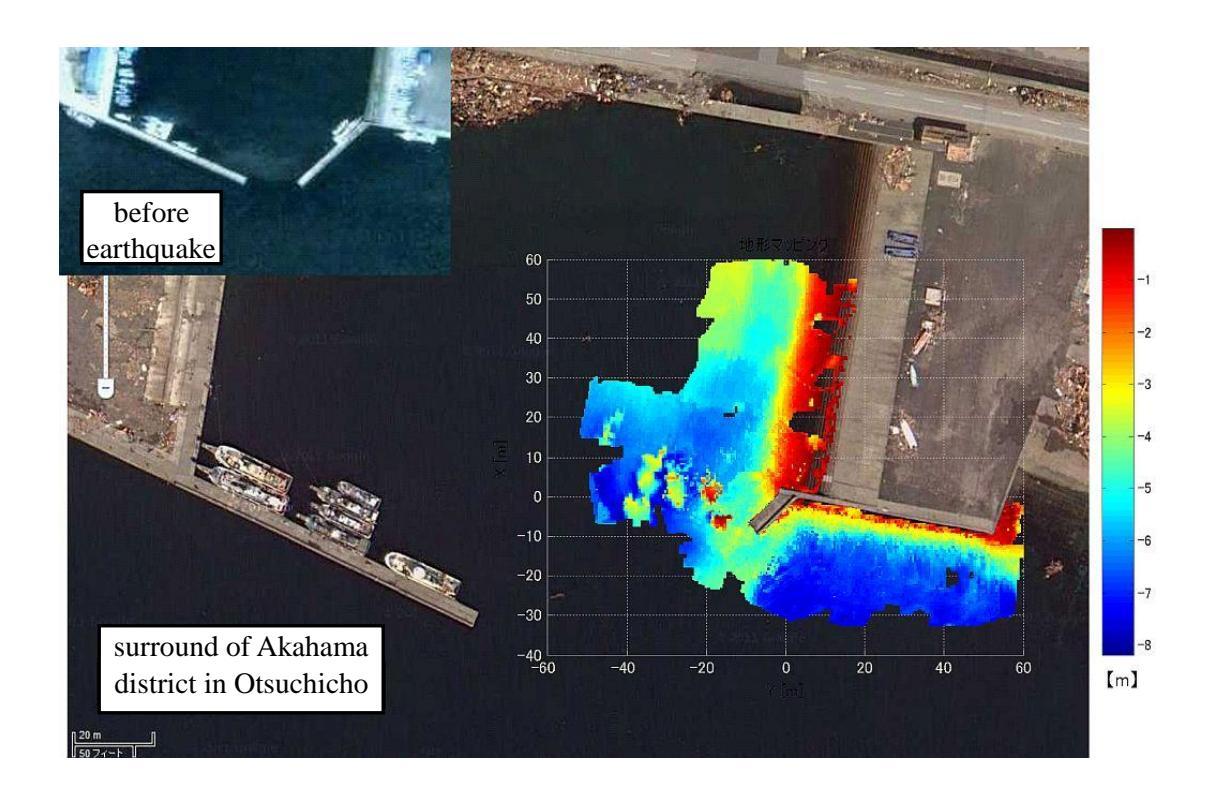
Fig.8 Bathymetry data obtained by the ASV. A photo of the area prior to the tsunami is shown in the top-left. Photos are from Google Earth (http://www.google.co.jp/intl/ja/earth/index.html).

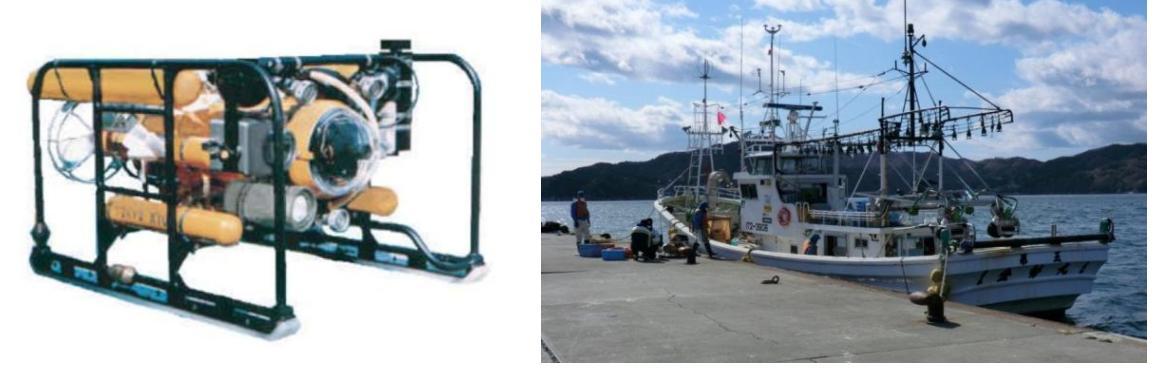
(a) Underwater vehicle LEO
(b) Fishing boat used for the investigation
Fig.9 ROV and the boat that were used in July 2011

During July 2011, the University of Tokyo Ocean Alliance conducted five visual surveys in collaboration with the Nippon Foundation and JF Zengyoren by using RTV-100 and the underwater vehicle "LEO", which was developed by Tokyokyuei Corp. (Fig.9(a)). During the first four surveys, the boat shown in Fig.9(b) was anchored at a predetermined location and the sea bottom around this location was surveyed by the ROV. The depth was 40–70 m. During the fifth survey, the investigation was conducted using side-scan sonar equipped on a different boat and 60 anchoring points were determined in accordance with the measured data. Then, the surrounding area of the points was surveyed by the ROV the next day. This proved to be a very efficient method and most of the debris in an area of $3,300,000 \text{ m}^2$ was identified in just 4 days.

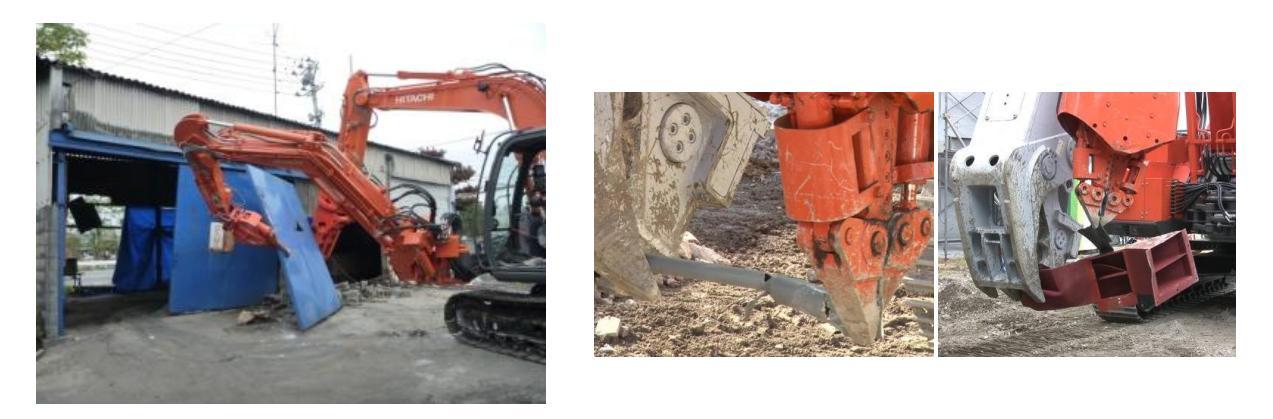
(a) Removing the doors of a damaged warehouse (b) Newly developed multifunctional hand Fig.10 ASTACO NEO was used to remove the doors of a damaged warehouse

A new construction machine, ASTACO NEO, with twin hydraulic arms, as shown in Fig.10(a), was employed to remove debris and dismantle a portion of a damaged warehouse in Ishinomaki at the southern end

of the Sanriku coast during May and June 2011. ASTACO NEO was developed during a project that was sponsored by the New Energy and Industrial Technology Development Organization (NEDO) (Yanagihara et al., 2009). One arm operates as the main arm that can be attached with commercial tools, such as 11-ton hydraulic shovels, and the other is a sub arm that can be attached with the newly developed versatile hand shown in Fig.10(b), which can grasp small objects at its finger tips and cut reinforcing steel at the base of its fingers. The degrees-of-freedom of the main arm is 5 and that of the sub arm is 9, both of which include their attachments. The main arm is controlled by the joystick on the right side and the sub arm is controlled by the joystick on the right side and the sub arm is controlled by the joystick on the right side and the sub arm is a passive powered suit developed by Prof. Tanaka of Hokkaido University, was used to reduce the loads of the workers when removing debris (Imamura et al., 2011).

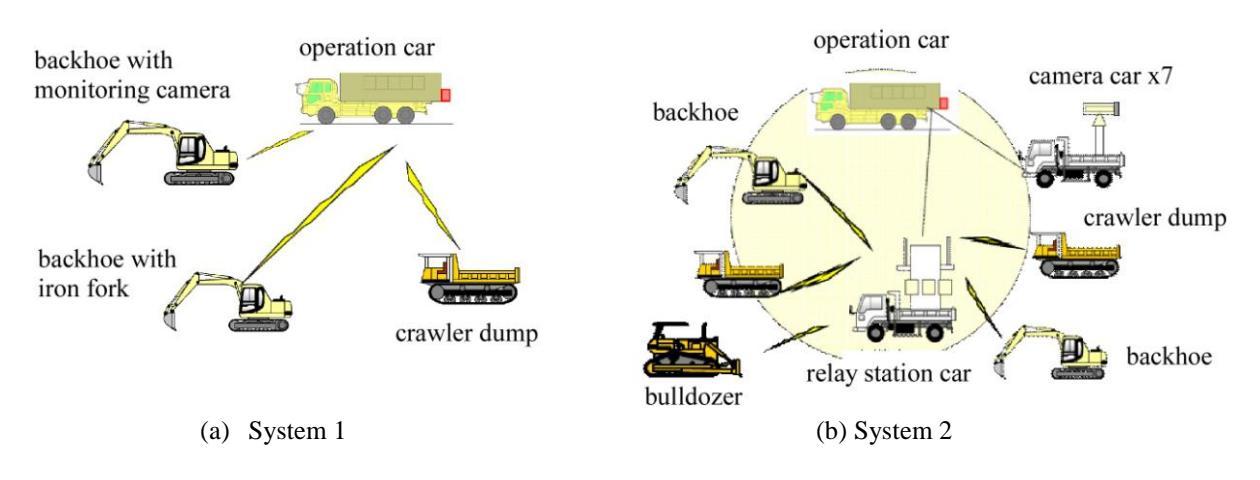
Fig.12 Configurations of the unmanned systems used to remove debris

Tele-operated construction machines modified for the disaster site were used to remove debris around the nuclear reactor buildings. At first, a backhoe with an iron fork attached to its tip, a crawler dump truck, a monitoring car with a camera, and an operation car were introduced as shown in Fig.12(a). The backhoe, dump truck, and monitoring car were tele-operated by operators in an operation car. Since the wireless communication range of this system limited the working distance to 150 m, it was impossible to use the system in high dose areas; thus, system 2 was introduced as shown in Fig.12(b). System 2 consisted of one operation car, one relay station car, seven camera cars, two backhoes, two dump trucks, and one bulldozer. The technologies installed in the tele-operation system were originally developed as unmanned construction technologies almost 20 years ago for the recovery activities of the evacuation of Mt. Unzen Fugendake and they have been continuously improved as construction robot technologies up until now (Yamamoto, 2007). At the time, there were about 20 skilled operators for unmanned construction machines in Japan, but it was impossible to place all the operators at the Fukushima Daiichi NPP, and the lack of operators was one of the most significant problems during the accident. It was also unclear whether the unmanned system would work well in high-radiation areas. If a machine became inoperable on an access road to the reactor buildings, the machine itself would have become a large obstacle that would seriously disrupt the recovery tasks. Despite these concerns it was determined to introduce the unmanned system into the disaster site.

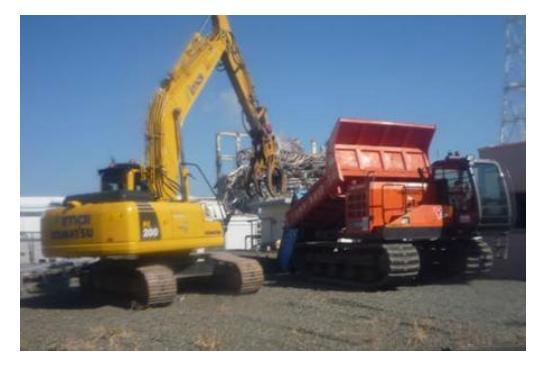
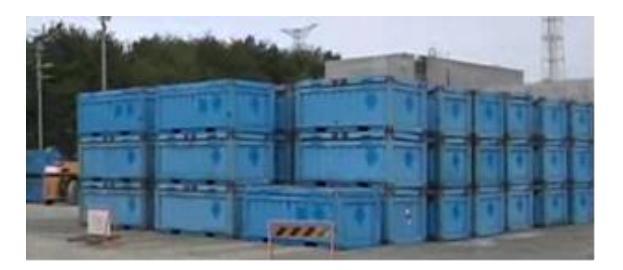
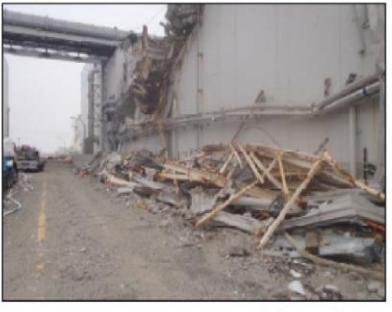
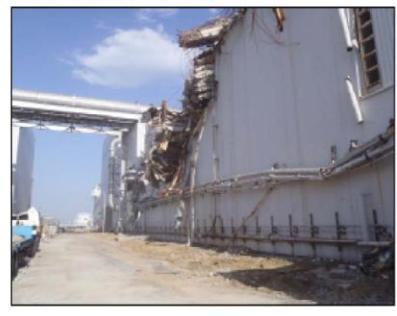
(a) Remotely controlled backhoe

(b) Stacked containers

before removal of debris

3/May/2011

after removal of debris

14/May/2011 (c)Road between reactor building 2 and 3

Fig.13 Removal of debris by the unmanned control system

close their flaps and used, but their radiation shielding ability was not high because they were designed for low level radioactive waste. All the debris was put into containers indiscriminatingly, as shown in Fig.13(a), and after being transported to the storage area, the containers were sorted according to the intensity of their radioactivity and stored as shown in Fig.13(b).

After introducing the unmanned system to remove debris, the level of the airborne radiation decreased. As the task became gradually easier, as shown in Fig.13(c), the applicable area became wider and almost 20,000 m^3 of debris was consequently removed from an area of 56,000 m^2 . The system worked very well and the outdoor debris was almost completely removed by the middle of November 2011.

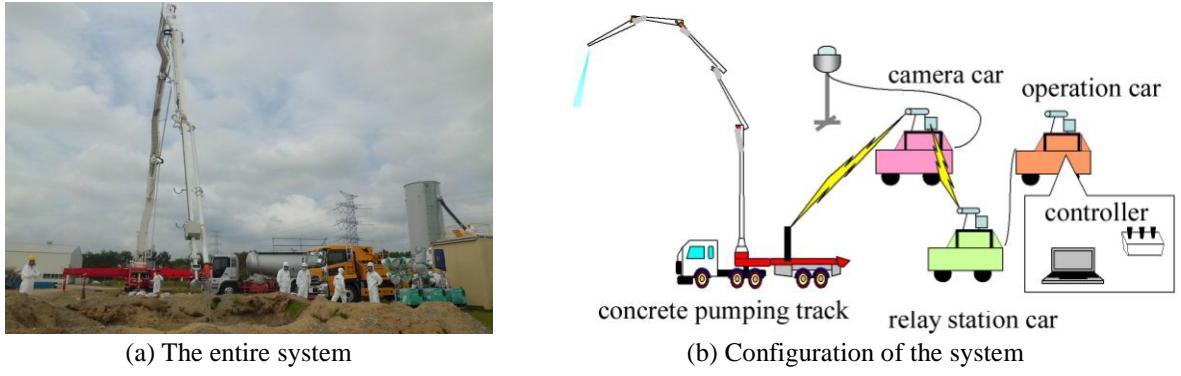
Fig.14 Remotely controlled concrete pump trailer

Just as the accident occurred, a periodic inspection was being conducted at reactor building 4, which had been eventually shut down. The pool of spent nuclear fuel on the top floor of the building was filled with the spent and unspent fuel removed from the reactor. A station blackout caused by the tsunami caused the water temperature in the pool to increase. If all the water in the pool had evaporated, most of the fuel in the pool would have melted down, producing levels of radioactivity so high that recovery would have been impossible. Therefore, pouring water into the pool was one of the most critical and urgent tasks immediately after the accident occurred. A modified concrete pumping track with a camera at the tip of the boom was used for the task and the water was successfully poured. It was then planned to continue this task remotely to reduce the radiation exposure of the workers, and three remote operation systems were developed. Fig.14 shows the entire system and the system configuration of Zousan 3, which consists of a concrete pumping track, an operation car, a monitoring camera car, and a relay station car. The three developed systems are similar, but they were not used in practice since the level of airborne radiation became low enough for workers to operate from the trailer when the systems were prepared.

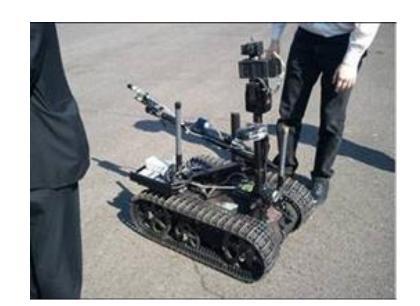
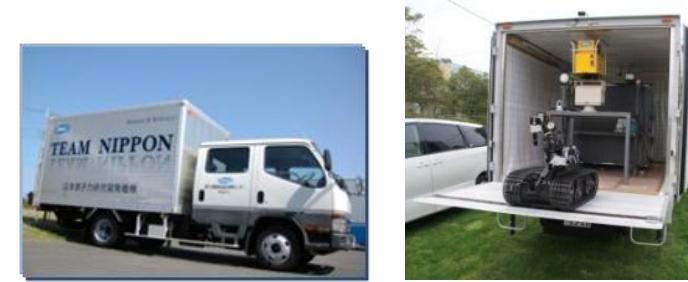
(a) TALON

(b) RC-1 (c) RC-1 being loaded with several tools Fig.15 Irradiation monitoring by TALON

A military robot, TALON, was provided to the Japanese government by DOE-INI on 14 April 2011 (Fig. 15(a)). TALON is equipped with a GPS and a radiation counter and can plot the obtained data on a geometrical map. The robot was expected to be used to monitor the outdoor radiation, but the roads were covered with debris, and the environment to operate the robot was very poor. Therefore, it was considered impossible to use only TALON. On the other hand, JAEA was developing RC-1 (Fig.15(b)), a truck on which a radiation shielding operation box is mounted. The shielding box has an 80-mm-wide steel sheet in front and operators can control the robots from inside of the box. TEPCO and JAEA developed a plan to transport TALON to the sites via RC-1 and tele-operate it from the box. In addition to the shielding box, a gamma-ray camera, laser range finder, thermo camera, radiation counter, and other small items were loaded into RC-1 as shown in Fig. 5.15(c). The gamma-ray camera displayed the intensity of the gamma rays by providing their corresponding colors on a screen, and it was very useful to locate the high-radiation debris around the large equipment hatch of reactor building 3 (Fig.16) and the exhaust air duct of reactor building 1. RC-1 and TALON were used on 5 May 2011. JAEA also developed another gamma-ray camera (γ -eye; Fig.17) that is more reliable than the previous one and a monitoring robot (J-3) that is based on RESQ-A, which was developed just after the disastrous nuclear accident in Tokaimura in 1999. To increase the radiation hardness and reliability, J-3 was remotely controlled via wiring and the motor drivers and the power source were placed in the shielding box. Due to this configuration, the radiation hardness increased 10^6 Gy. The motion range of J-3 was 50 m, which was determined by considering the weight of the cable that had a diameter of 20 mm and the maximum traction force of J-3. J-3 was loaded on to a new truck that had a shielding box and an air conditioner (RC-2), and was used to monitor gamma rays in reactor building 2 on 23 September 2011 (Kawatsuma et al., 2012).

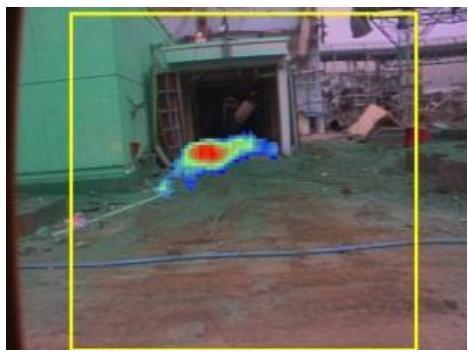
Fig.16 Image obtained by the gamma-ray camera around reactor building 3

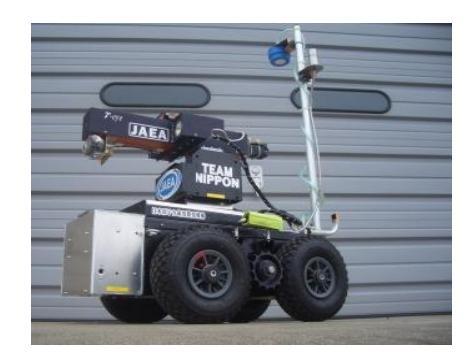
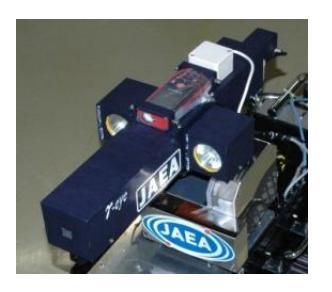
(a) Remotely controlled robot J-3 with the γ -eye camera (b) γ -eye camera Fig.17 Newly developed irradiation monitoring robot J-3

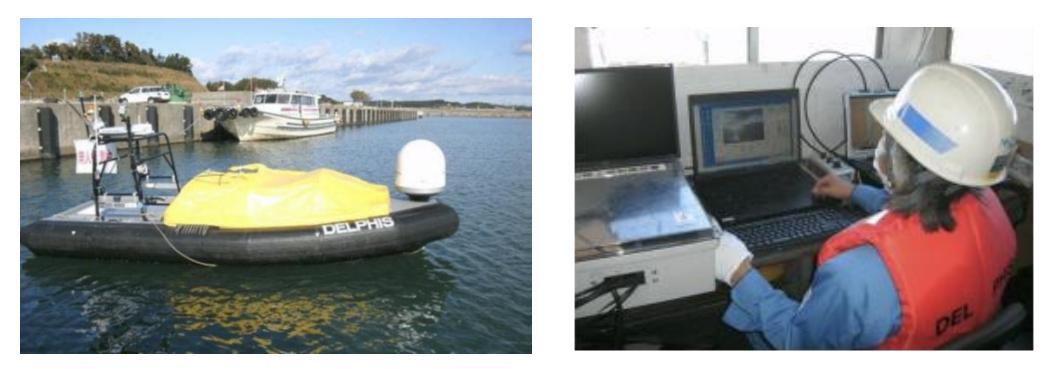
(a) USV (b) Operation site Fig.18 Unmanned surface vehicle (USV) used to monitor irradiation

Irradiation was also monitored at sea around the Fukushima Daiichi NPP by an unmanned surface vehicle (USV) (Fig.18), which can be autonomously controlled by using a GPS along a target path consisting of a series of given points on a map. Immediately after the earthquake, there was a lot of debris on the sea surface, and it was almost impossible to control the USV autonomously. Therefore, the USV was autonomously controlled, but the view ahead of the USV was also given to the operator on the ground. If an obstacle was found in the view, the operator sent the control command for collision avoidance to the vehicle. Then, the given command overrides that generated by the USV. To increase the robustness of the control system, four wireless communication systems were implemented (wireless LAN, FOMA, VSAT, and WIDESTAR) in order of priority. The length, width, and height were 6.0 m, 2.3 m, and 0.9 m, respectively, and its weight was 1.8 tons. The maximum velocity was 7 knots/hour and that during monitoring was 3 knots/hour, and the maximum sailing distance was about 100 km. In addition to the GPS compass and wireless communication systems, water samplers, a gamma dosimeter, and an acoustic doppler current profiler (ADCP) were equipped to the USV. TEPCO began operating the USV on 11 November 2011. The USV started at the Fukushima Daini NPP and sampled water at 26 points and measured gamma rays in real time off the coast of the Fukushima Daiichi NPP. The USV was unmanned, the total operation time was 3 hours and 40 min, and the sail distance was 40 km.

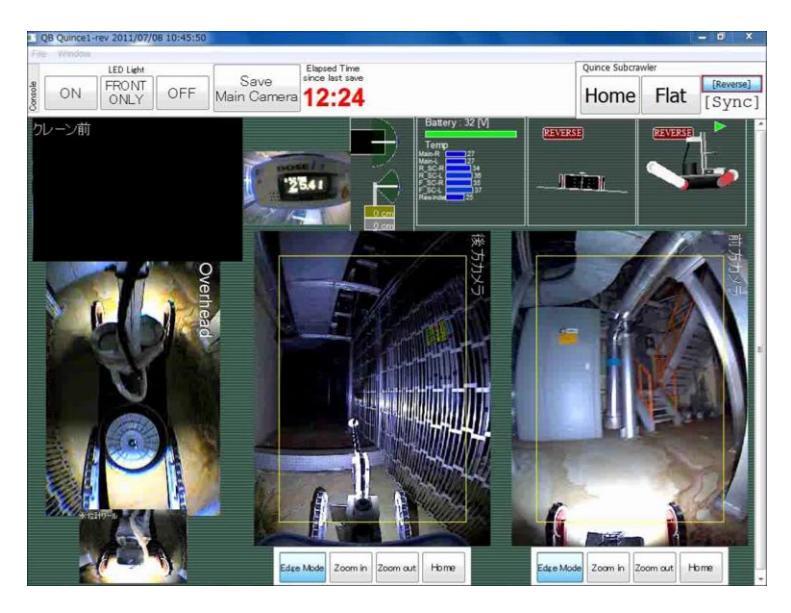
Fig.21 Operation panel of Quince

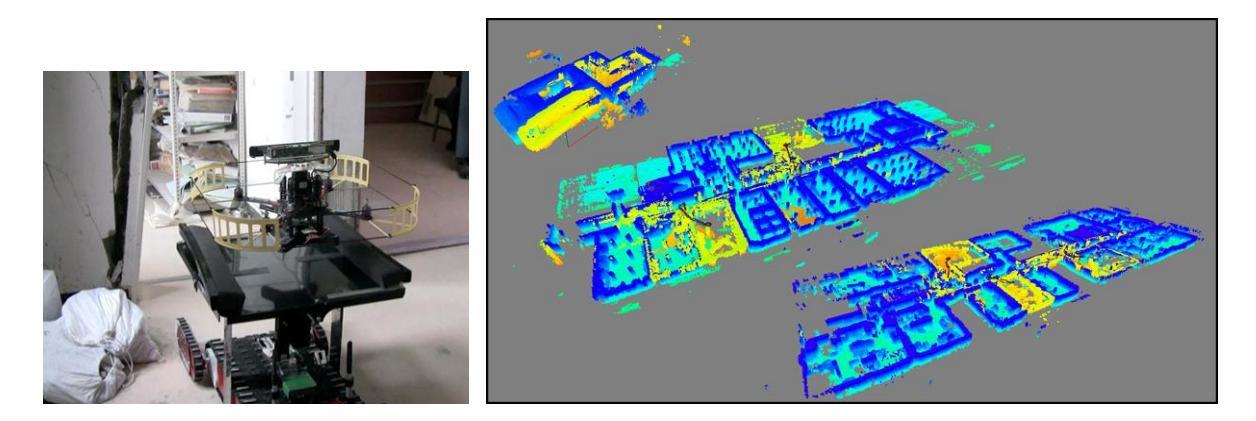
Fig.23 Inspection of a damaged building conducted in collaboration with Quince, Pelican, and Kenaf

Quince was also used to inspect the damaged buildings of Tohoku University in collaboration with a quad rotor helicopter (Pelican) and a rescue robot (Kenaf), which is the base robot of Quince, in July 2011 (Fig.23). A 3D map of the interior of the damaged building was also created (Michael et al., 2012).

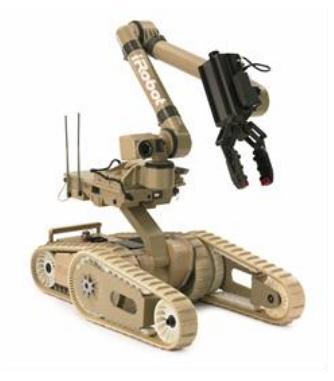
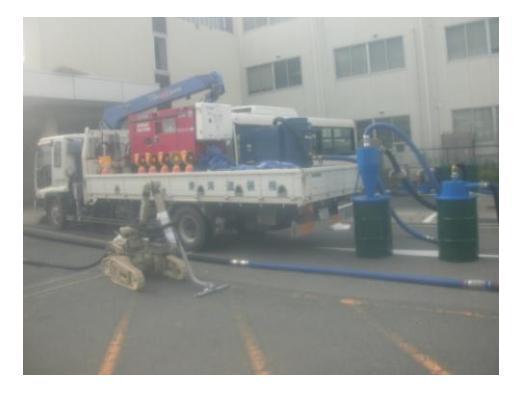
(a) 710 Warrior
(a) Quince and Pelican
(b) 710 Warrior equipped with a cleaner
(http://www.tepco.co.jp/en/news/110311/images/110630_4.jpg)
Fig.24 710 Warrior that was used to clean the floors in the reactor buildings

Some robots were used to remove radioactive debris and to clean the floors in the reactor buildings. The robot that was primarily used was a military commercial robot (710 Warrior) (Fig.24(a)) developed by iRobot

Corp. In June 2011, 710 Warrior began cleaning the reactor buildings indoors. A cleaner is attached to the manipulator tip of 710 Warrior, as shown in Fig.24(b). iRobot Corp. provided two 710 Warriors: one with a heavy manipulator arm, and another with a universal vice with a hose clamp. The robot is a ground vehicle that utilizes tracks rather than wheels. The structure of the chassis consists of a drive mechanism paired with a flipper of the same size, the deck platform, and the base/arm coupling that is connected between the components. The heavy manipulator arm, universal vice, or any other payload can be installed on the deck platform. The chassis length is approximately 89 cm when the flippers are folded and the width is 54 cm (77 cm with flippers). The heavy manipulator arm has two links, but the deck platform, which can be lifted up and down and swivels forward and backward, provides a third link equivalent to an arm and an additional degree of freedom axis. The heavy manipulator arm is capable of lifting and handling approximately 99 kg. With a weight of approximately 200 kg, 710 Warrior has a mobility of over 12 km/h when the heavy arm is installed. It also has a radio and a wired communication mode when using the Operator Control Display Unit (ruggedized laptop PC), and can be operated by a hand controller. The use of 710 Warrior to clean the reactor building entrances was publicized in June 2011. The robot holds the dust collection nozzle and pulls the hose of the cyclone cleaner. It was used to review heavy shield transportation scenarios and to clean interior debris.

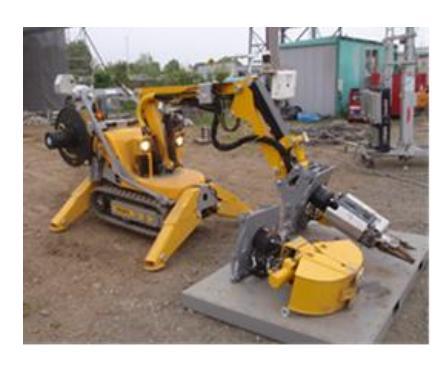
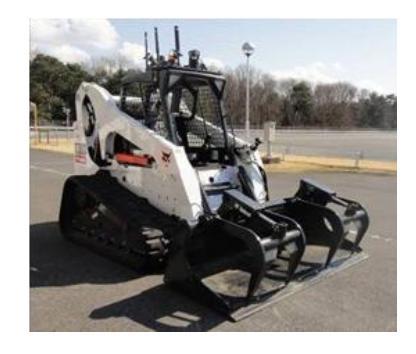
(a) BOBCAT (b) BROKK Fig.25 Remotely operated robots used to remove indoor debris

Three other robots (TALON, BOBCAT and BROKK) (Fig.25) were used to remove debris around the heavy equipment hatch of reactor building 3. BOBCAT is a commercial unmanned construction vehicle developed by QinetiQ. BROKK is a remote controlled demolition robot for nuclear power plants; two BROKKs (BROKK-90 and BROKK330) were used. One was controlled via wires and the other was wirelessly controlled around the hatch.
